ACT FORESTS BRANCH

STROMLO TRAIL BIKE AREA - IMPACT ASSESSMENT REPORT NUMBER ONE (W.L. Bloomfield, K.J. Roberts, B.J. Terrill)

STROMLO TRAIL BIKE AREA - IMPACT ASSESSMENT REPORT NO. 10 - OCTOBER 1977

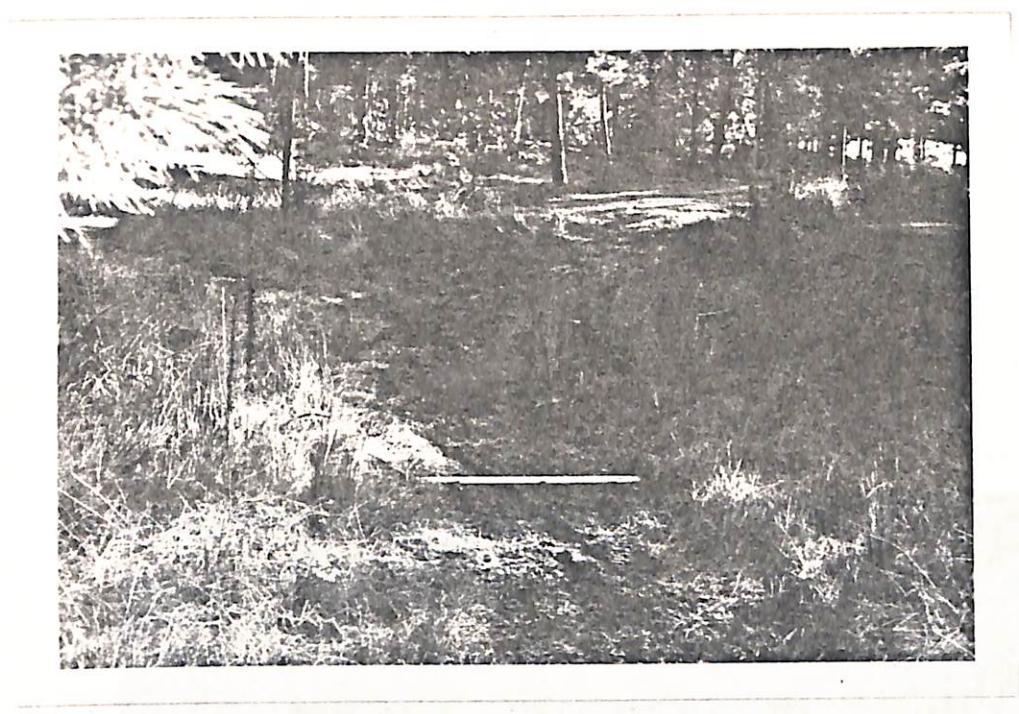
Plate 1. A well used trail located in a northern section of the trail bike area, (May, 1974).

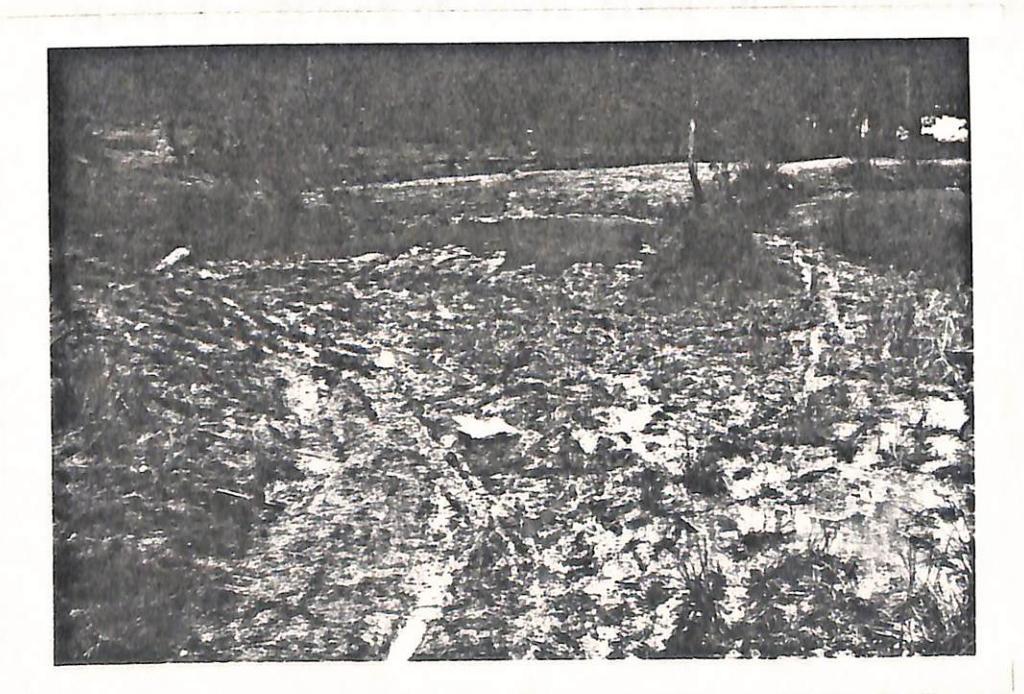
The type of impact that occurred is illustrated in Plates 1 - 12. The interaction of damp, damage prone soil and rider behaviour quickly produced the effect shown in plates 1 and 2. A widening of the trail and loss of ground cover can be seen. In the grassland section of the trail bike area the sudden appearance of a water seepage on a trail attracted riders and a quagmire section (Plate 3) was formed. Nearby, increased traffic resulted in ground cover reduction over a wide section where previously only a narrow trail was present (Plates 4 and 5).

Plate 2. The same trail in late September, 1974. Note loss of ground cover, increase in trail width and disturbance of top soil.

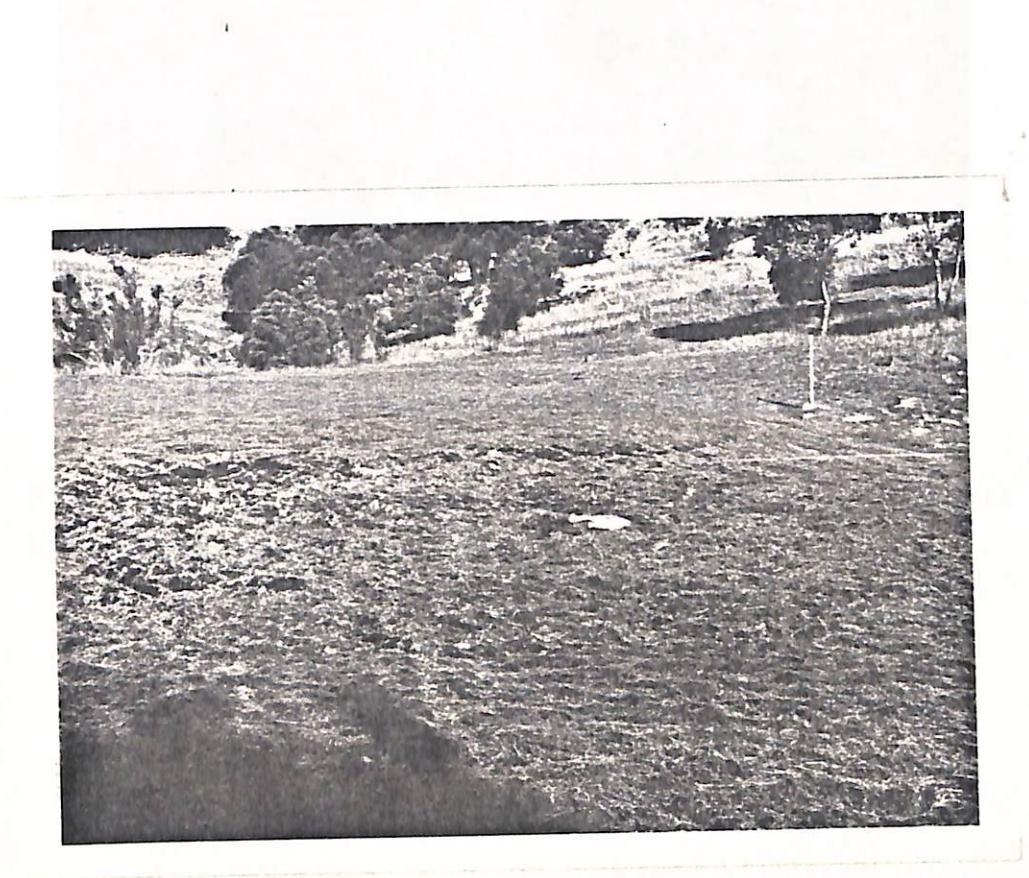
Plate 3. Effect of trail bikes on a formerly grassy area after a water seepage had attracted heavy usage by riders, (May, 1974).

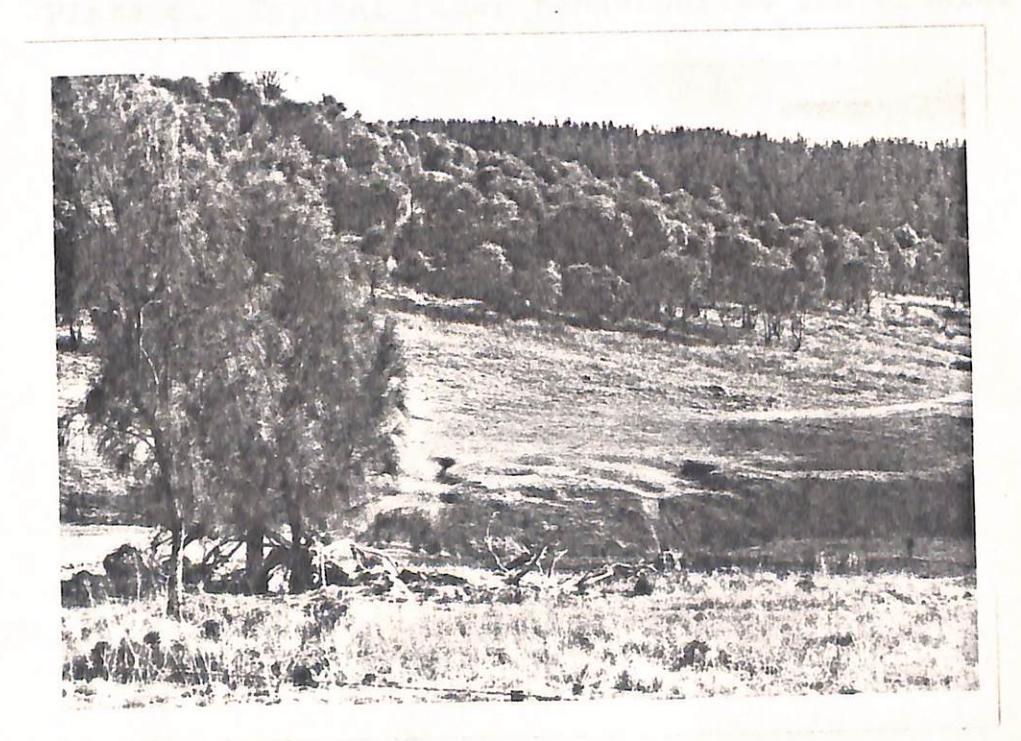
Plate 5. The same area in June 1974. Previously, disturbance of ground cover had been confined to a narrow trail but heavy usage by trail bike riders soon led to a large section of bare ground.

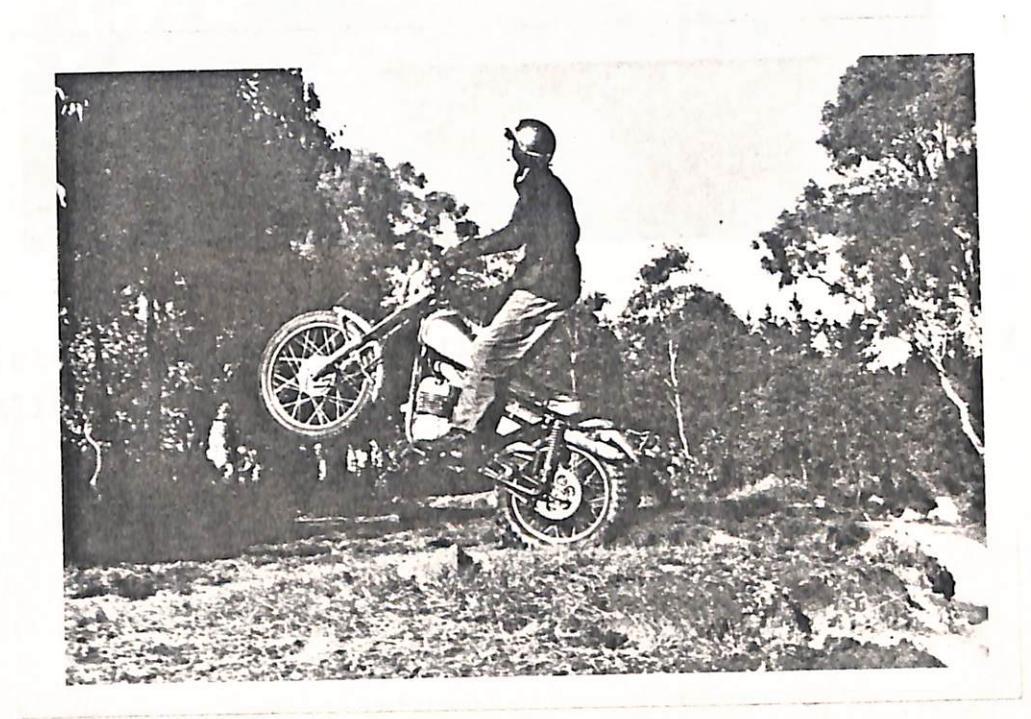
Plate 6. Typical rider behaviour at the erosion gully.

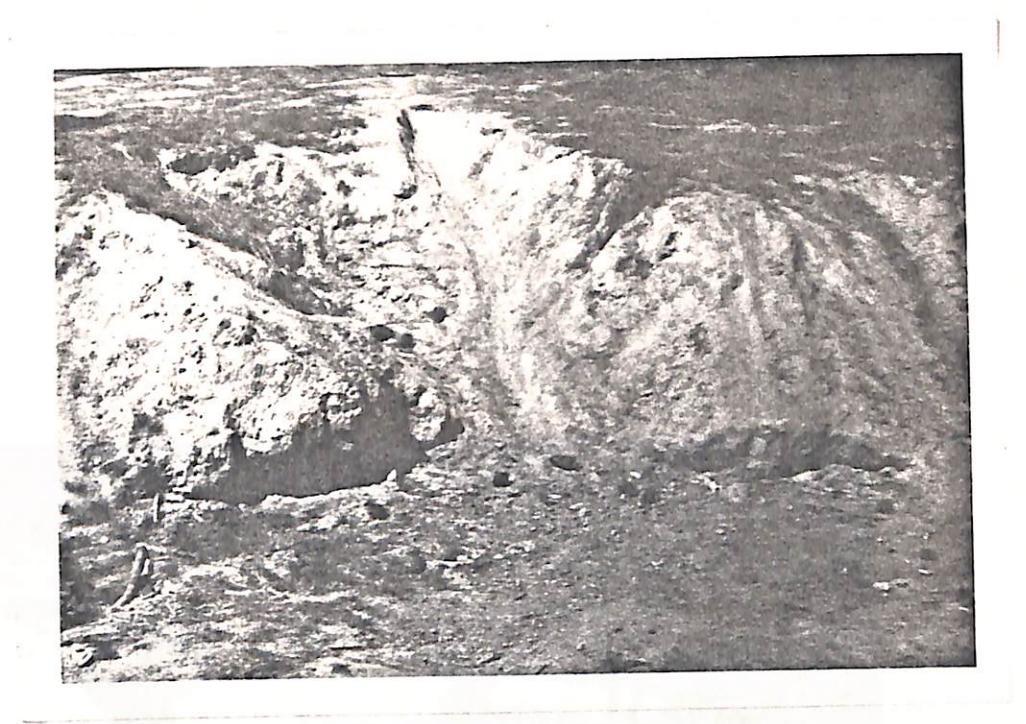
Plate 7. Effect of trail bikes on the erosion gully walls.

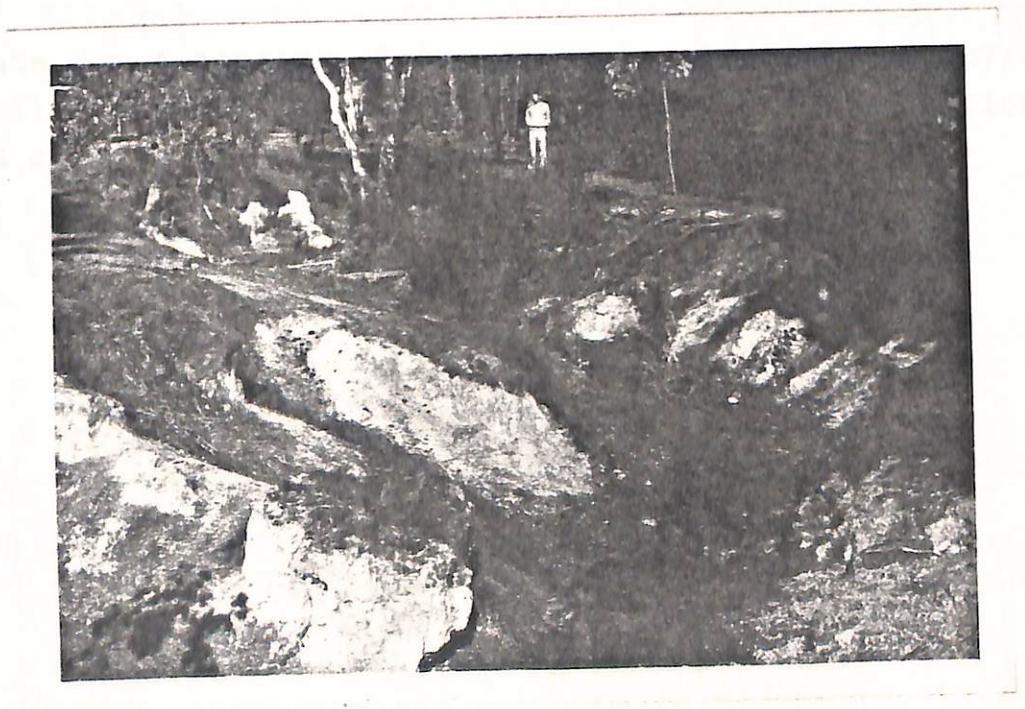
Plate 8. Part of the erosion gully in May 1974. Soil has been moved off the gully walls by trail bike activity and has accumulated on the gully floor.

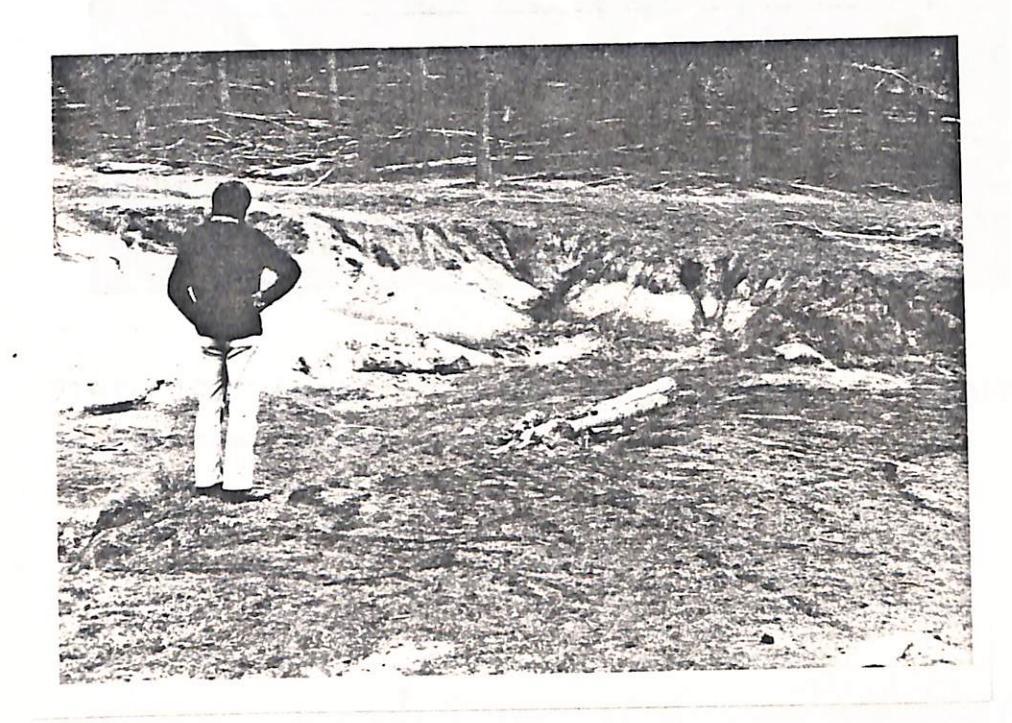
Plate 9. A section of the erosion gully in June 1974. Trail bike activity has led to ground cover reduction and erosion of the gully walls.

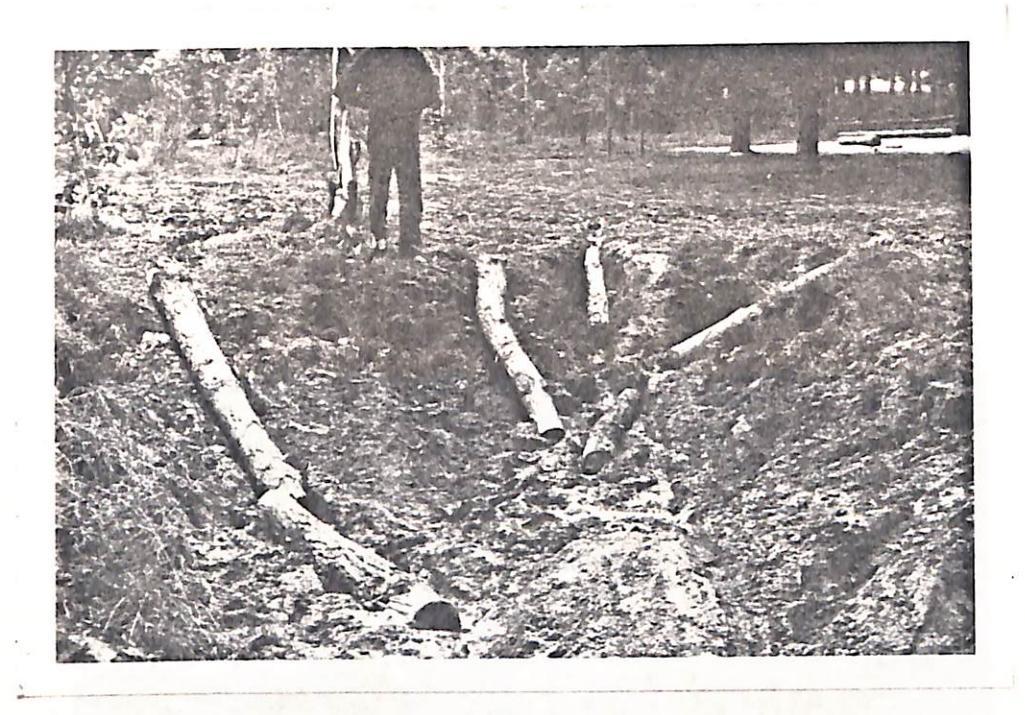
Plate 10. Logs were used in an attempt to control erosion in furrows caused by trail bikes.

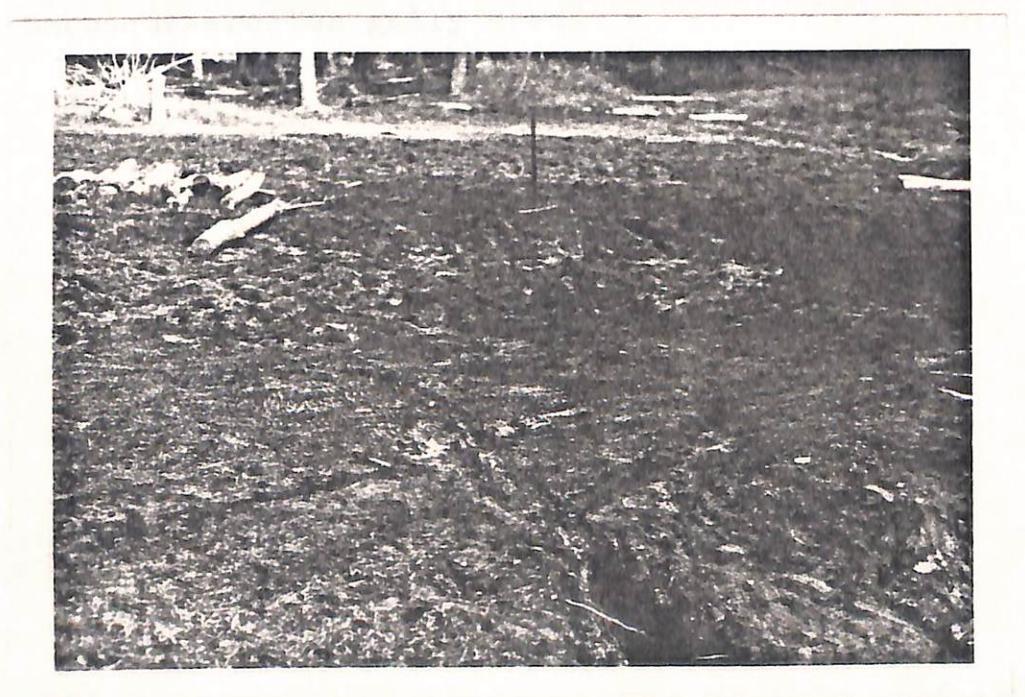
The problem of greatest concern however, came on gently sloping, formerly grassy areas near the gully. Some reduction in ground cover had occurred here prior to rain but the combination of wet conditions, sparse ground cover and intense use by riders soon led to quagmire sections as shown in Plate 11.

Plate 11. A large quagmire section on a gently sloping formerly grassy area near the erosion gully.

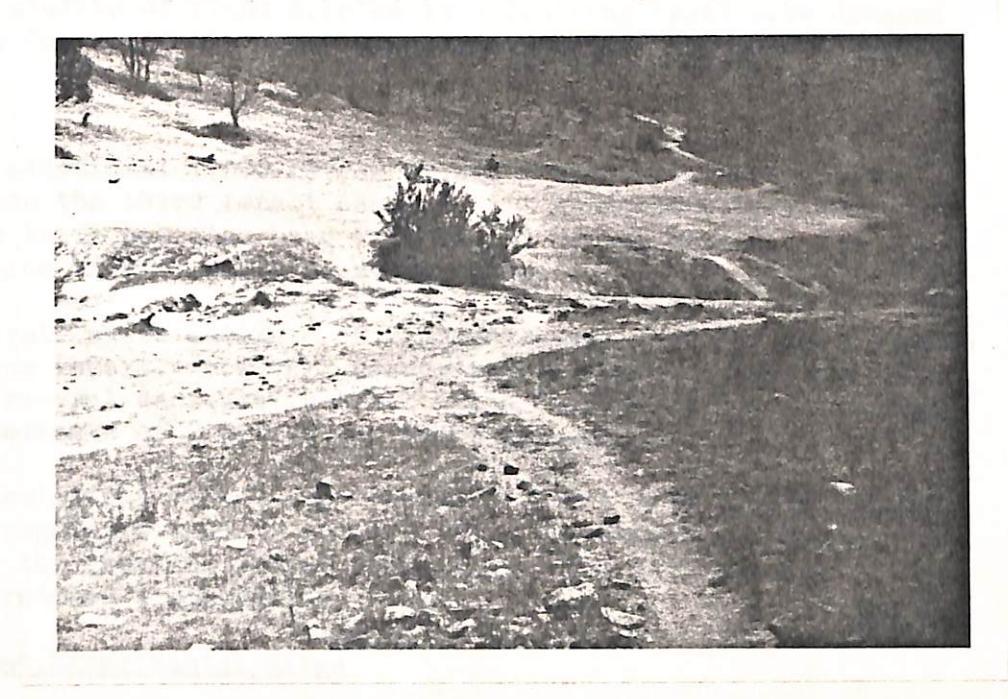
Plate 1 The former quagmire in the open grassland section of the trail bike area. Heavy usage had continued at this site and there is no evidence of revegetation.

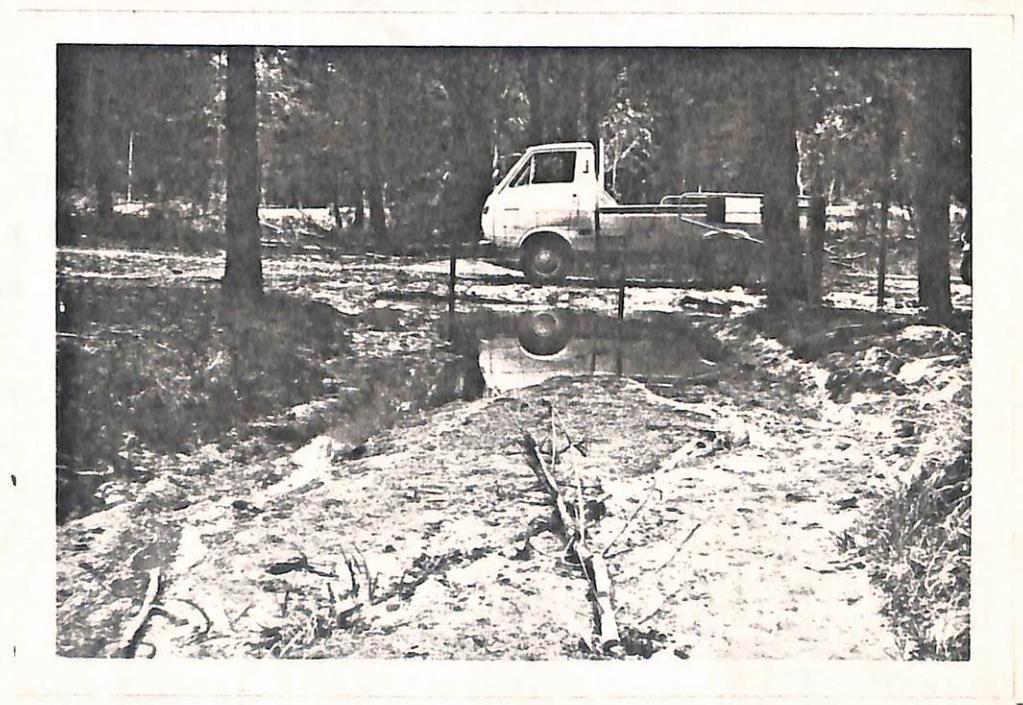
Plate 6 The same site in September 1974. The log is now almost covered by sediment and the colvert is blocked with mud.

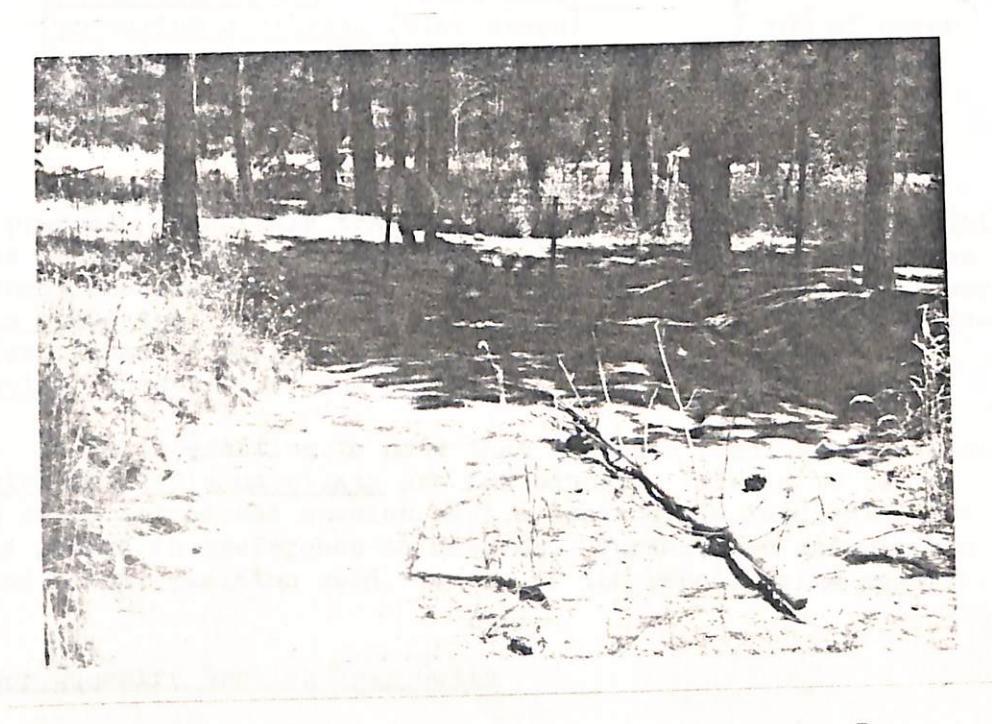
Plate 7 Gully profile experiment site in January 1975. The log referred to previously is completly covered by sediment. The situation shown in Plates 5,6 and 7 can be seen diagramatically in Fig 1.

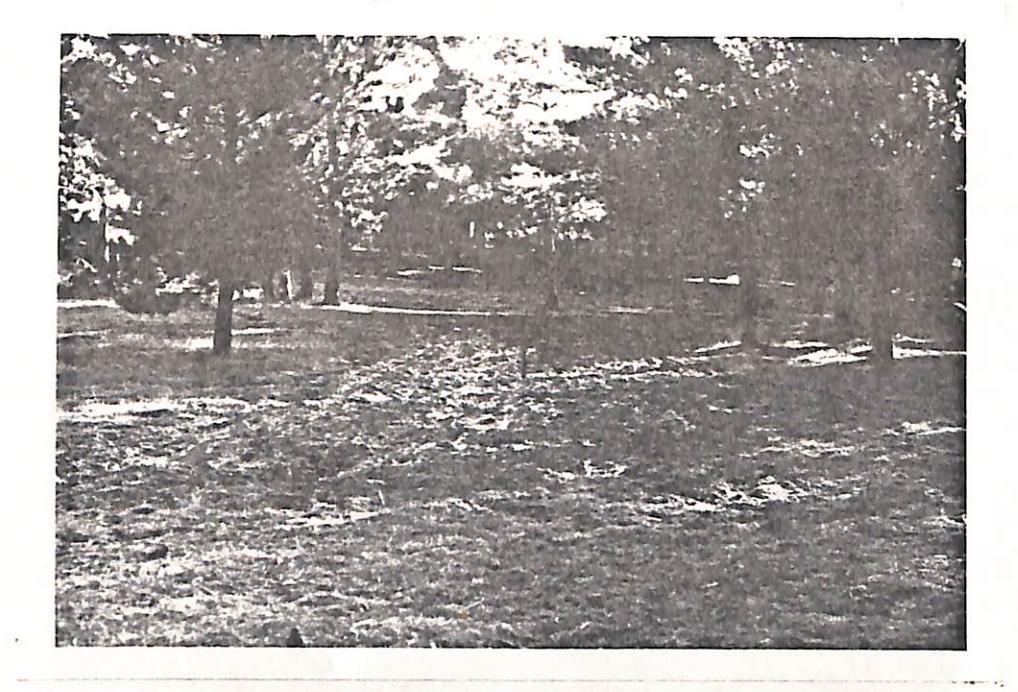
Plate 8 Quagmire before the gully section was closed to trail bikes, (May 1974).

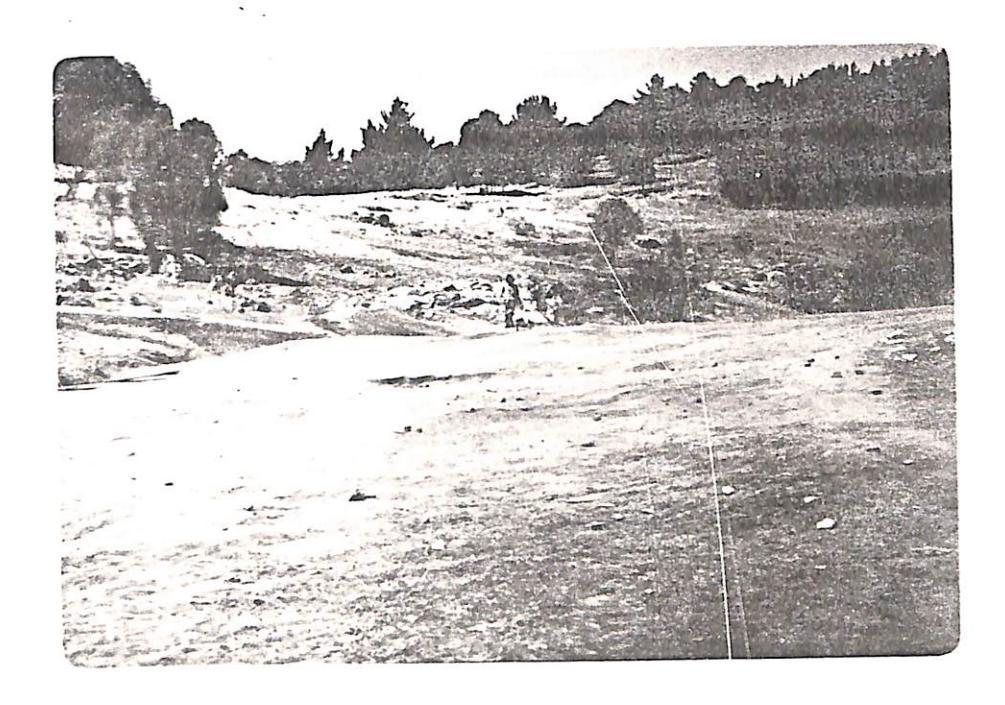
As seen in Plate 1, the latter area has become completely bare. However the impact can be tolerated because this section is located away from the public eye, and has proved attractive to riders thus diverting usage away from the carpark/barbeque area.

Plate 1: The section of bare ground near Opt 146

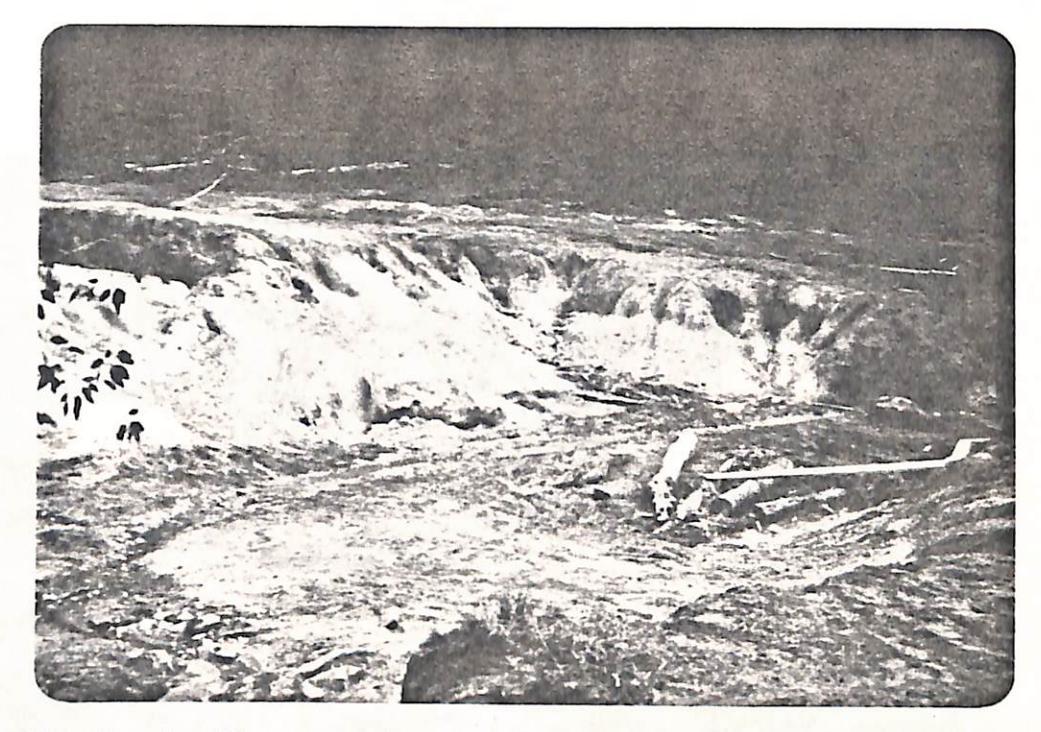
Plate 1 The erosion gully in Cpt 141 proved very popular with trail bike riders. Overuse produced the conditions shown in the photograph (Sep. 1974).

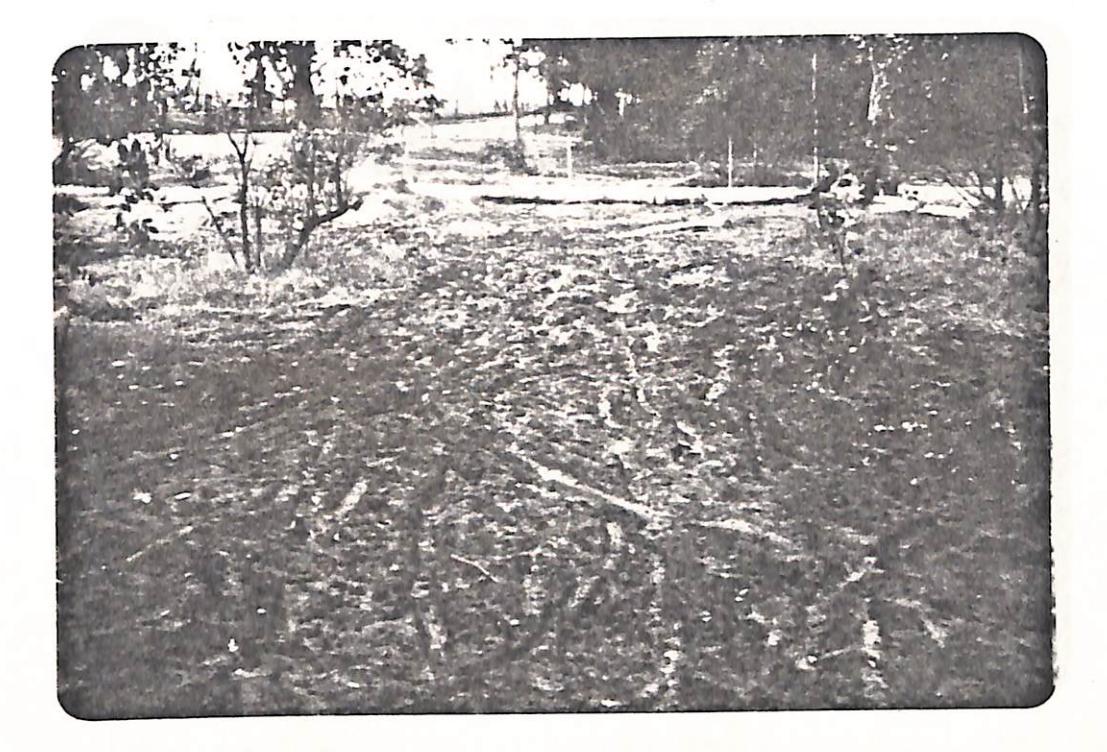
Plate 9 Another quagmire near the entrance gate. There has been no motorcycle use since July but little revegetation has taken place at this stage. (September 1974)

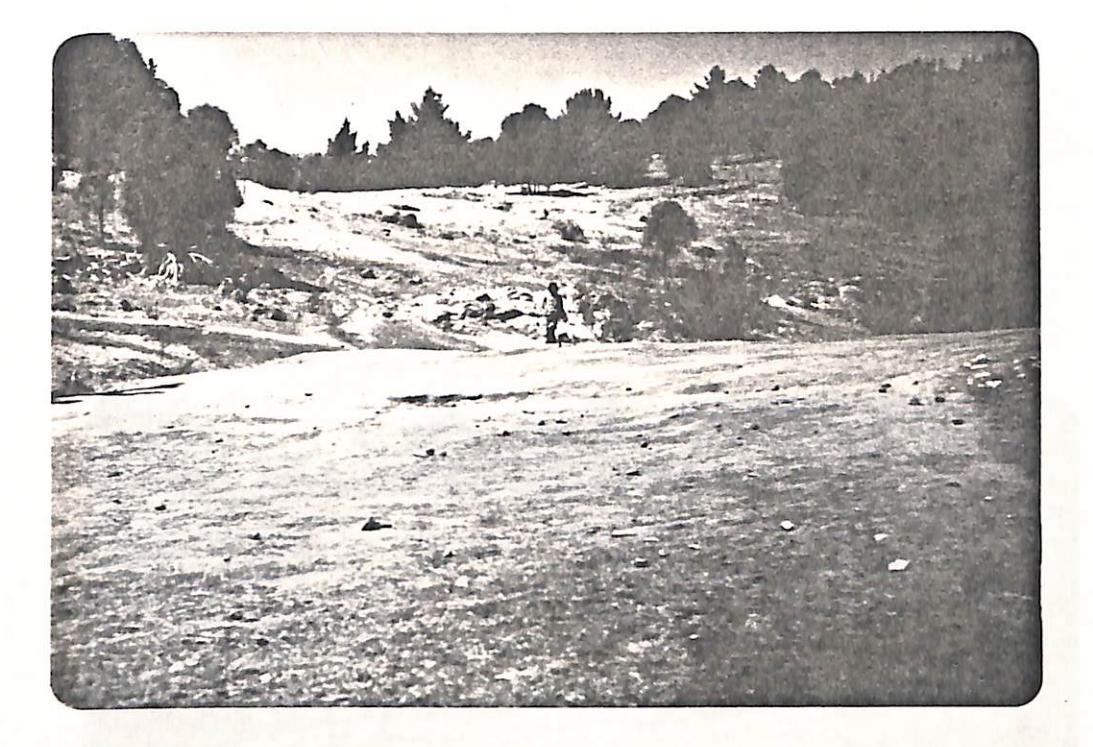
Plate 11 The large bare area near Cpt 146. (October 1974).

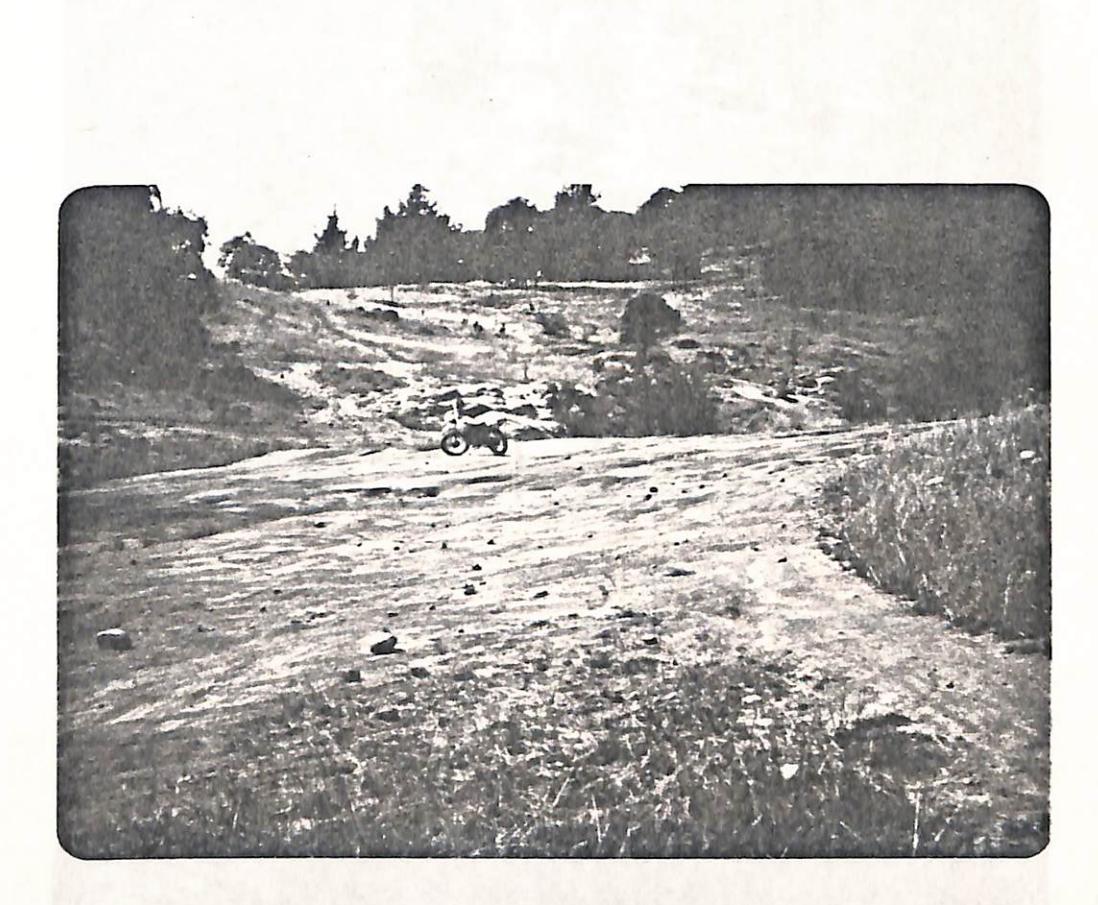
Plate 13 The same area in February 1976. Little, if any revegetation has taken place.

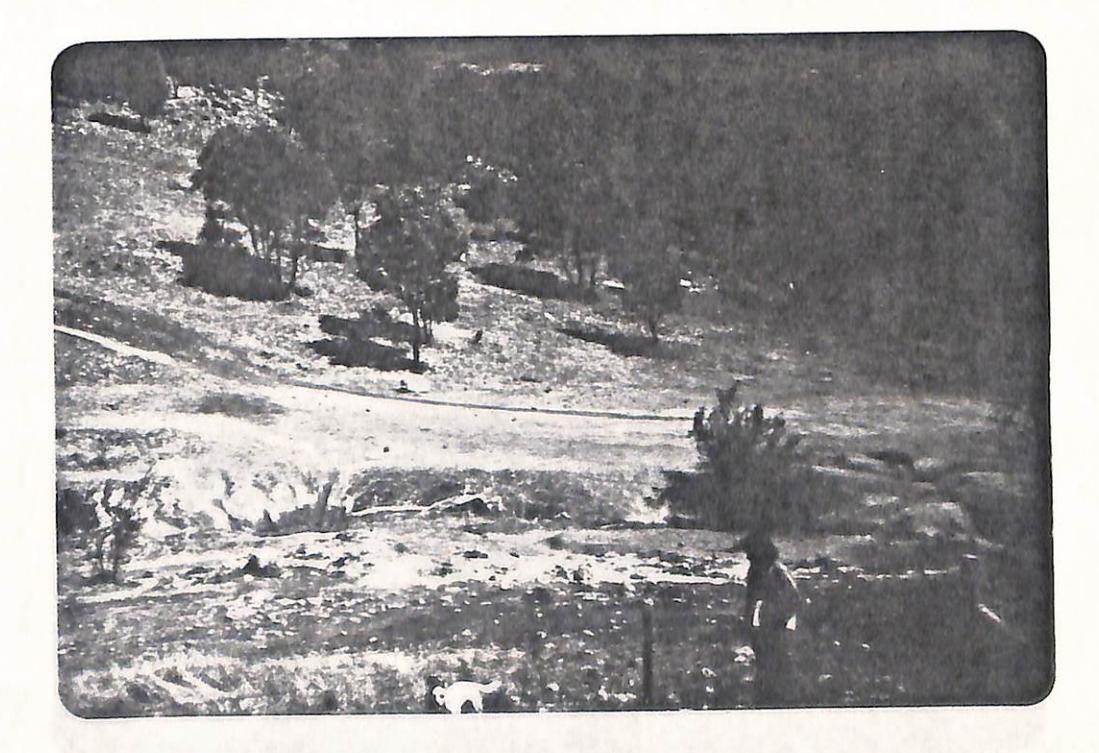
Plate 15 October 1974. The same section following heavy use by motorcycle riders.

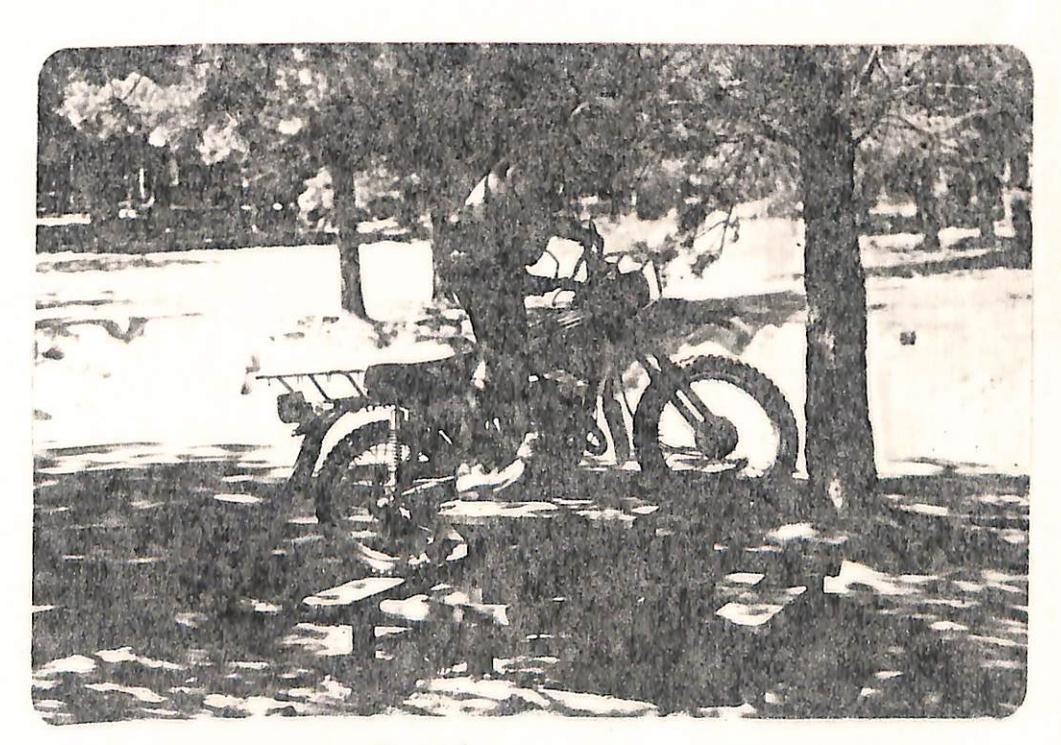
Plate 1

The lower picnic table vandalism is of an unusual type and this is shown in plate 1.
