ACT FORESTS BRANCH

STROMLO TRAIL BIKE AREA - IMPACT ASSESSMENT REPORT NUMBER ONE (W.L. Bloomfield, K.J. Roberts, B.J. Terrill)

STROMLO TRAIL BIKE AREA - IMPACT ASSESSMENT REPORT NO. 10 - OCTOBER 1977

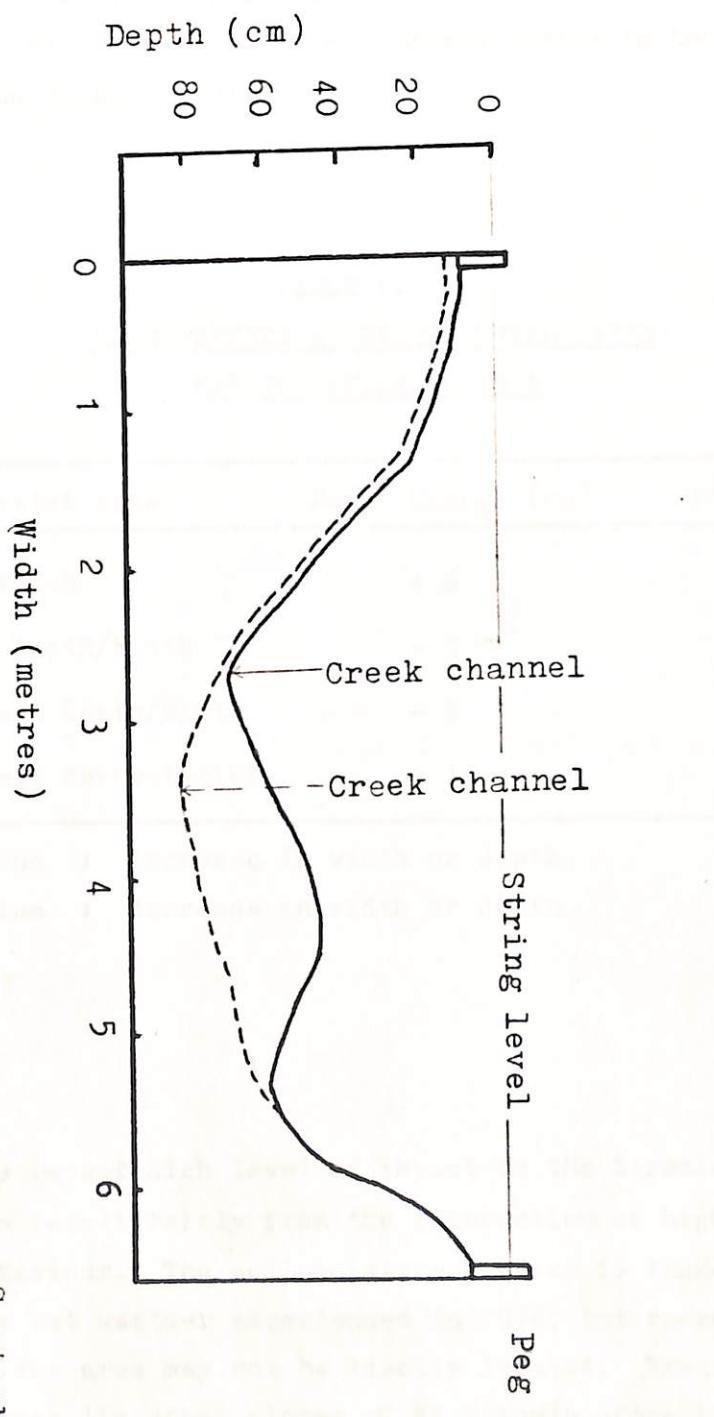
FIG 1

The gully depth experiment is located in the middle of the main gully but the gully profile experiment is near the bottom. Table 1 reveals that 8 cm of material has been lost from the mid-gully and as seen in Fig. 1, a substantial amount of sediment has been deposited at the bottom. Evidence of soil movement from the upper gully vicinity has already been mentioned. It is probable that sediment is also collecting in the dam.

GULLY PROFILE, STROMLO TRAIL BIKE AREA

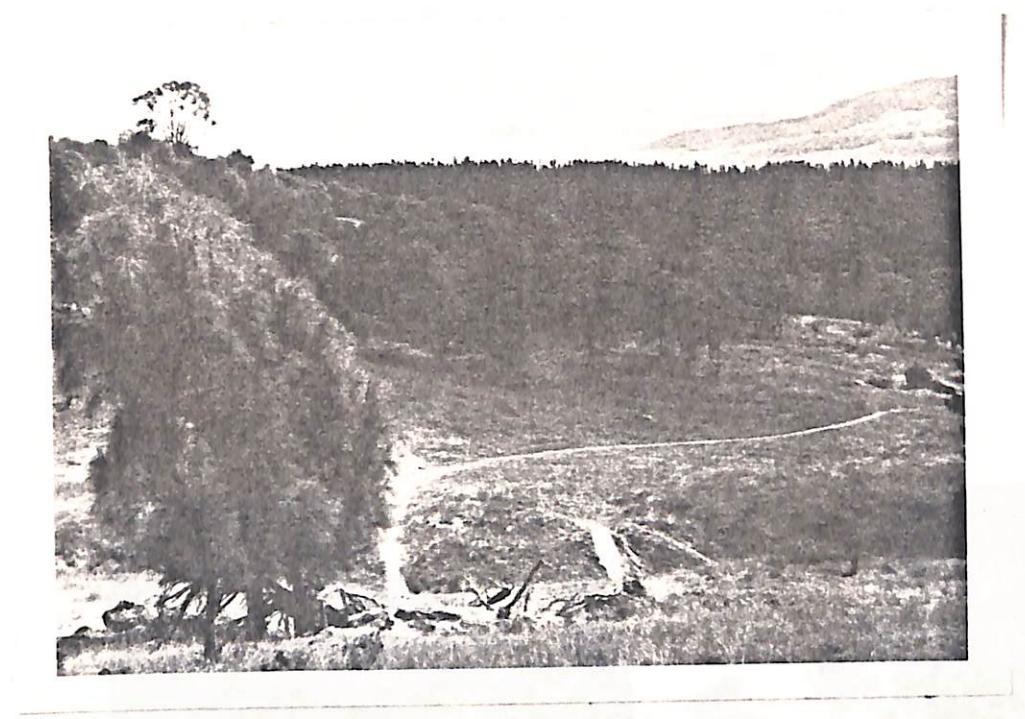
Plate 4. A trail in an open section of the trail bike area in March, 1974.

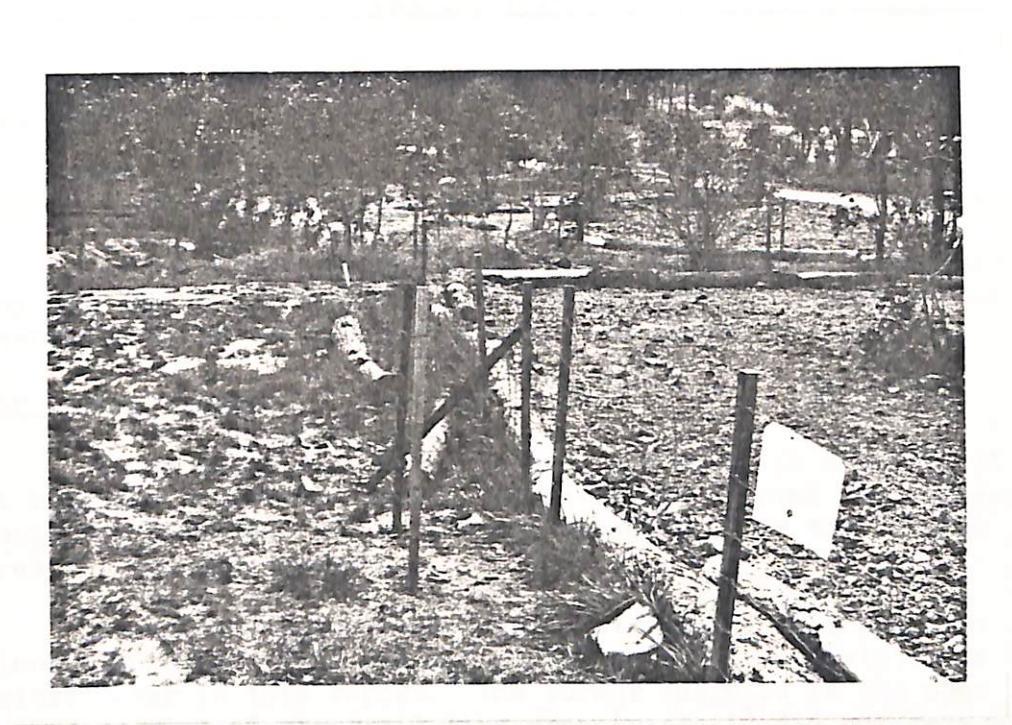
Plate 12. A pedestrian gate in the fence erected around the barbeque-erosion gully area.

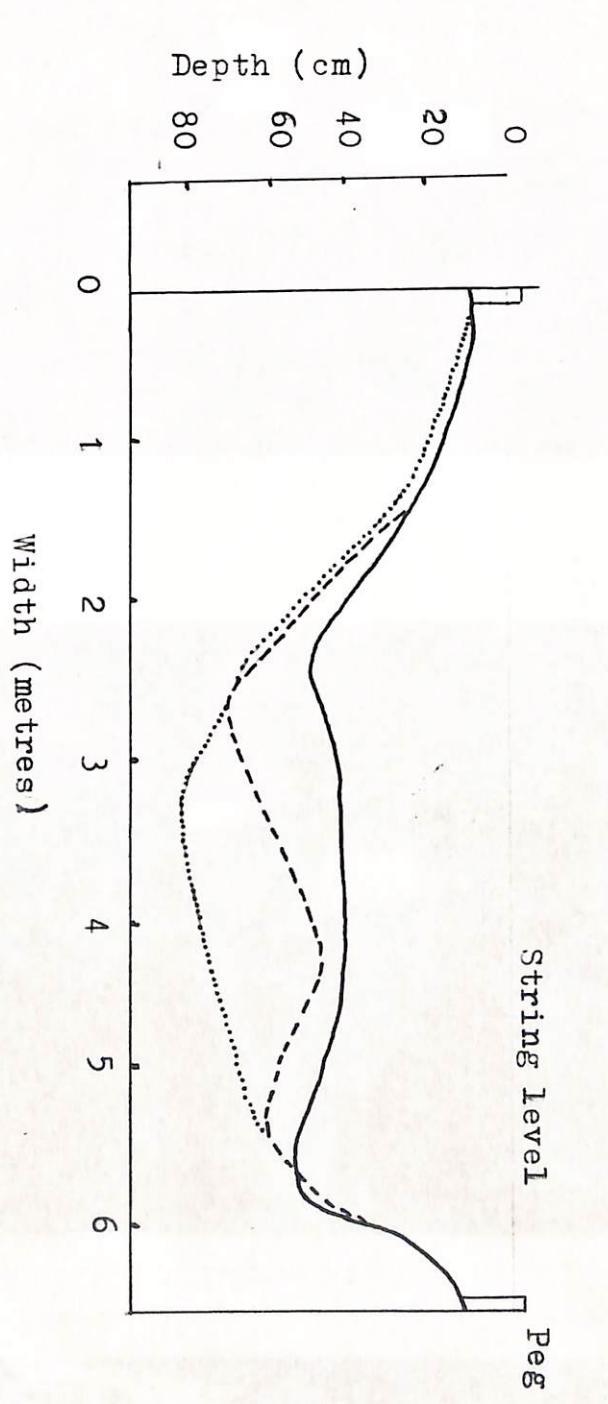
FIG 1 GULLY PROFILE, STROMLO TRAIL BIKE AREA

Unlike previous measurements, the gully depth experiment showed a decrease. This is obviously due to sedimentation but the reason for the change is not certain. It may be caused by decreased velocity of water in the gully, due to a large build up of sediment (Fig. 1, Plates 5, 6 and 7) in the vicinity of the gully profile experimental site. This continuing sediment build up may be partly linked with heavy use of the area between the main entrance gate and the four wheel drive barrier. Loose soil up to 2 cm in depth was noted over much of this area. MAP 1

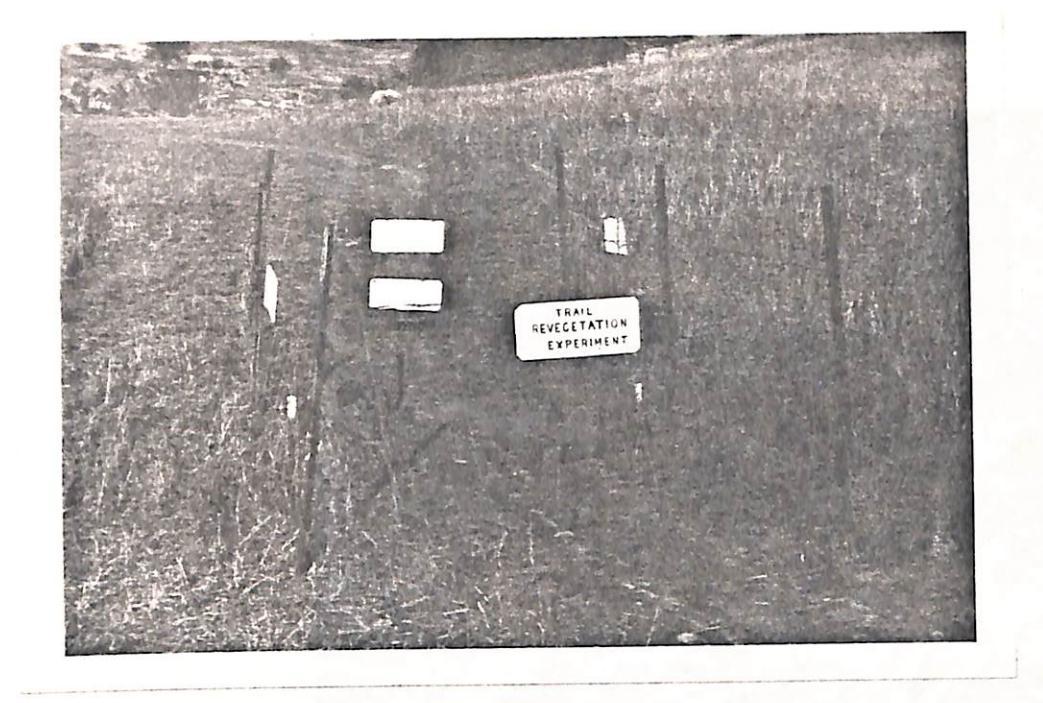
The increase in depth at the trail revegetation experiment is probably due to erosion. The trail edges are no longer clearly defined. Changes at the trail revegetation site have been recorded also by photography, (Plates 2, 3 and 4).

Plate 2 Revegetation experiment May 1974

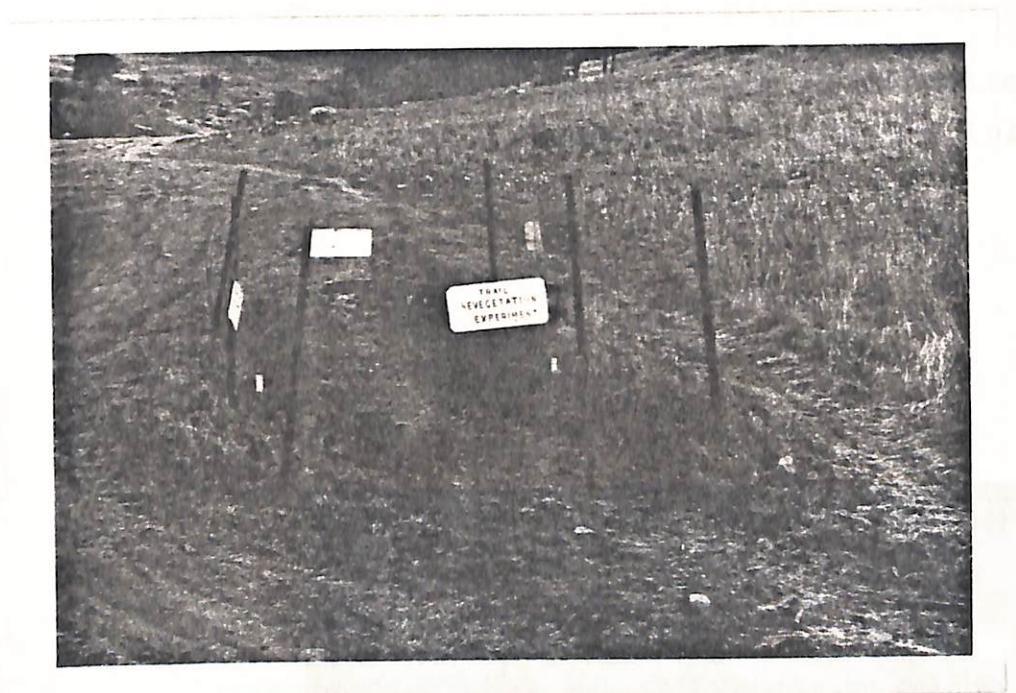
Plate 3 September 1974

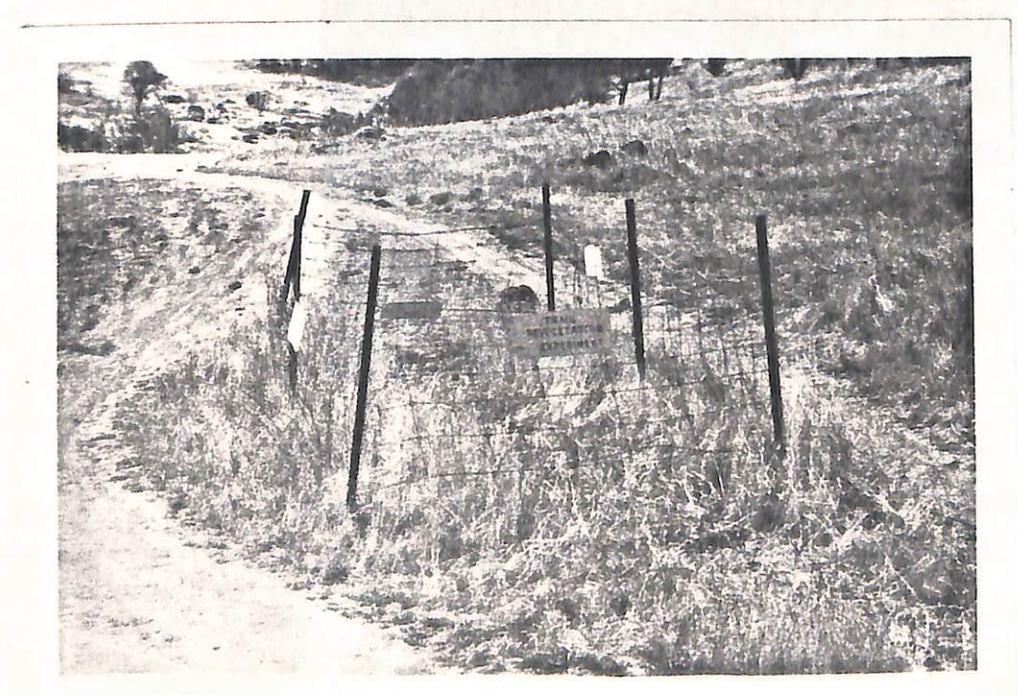
Plate 4 January 1975

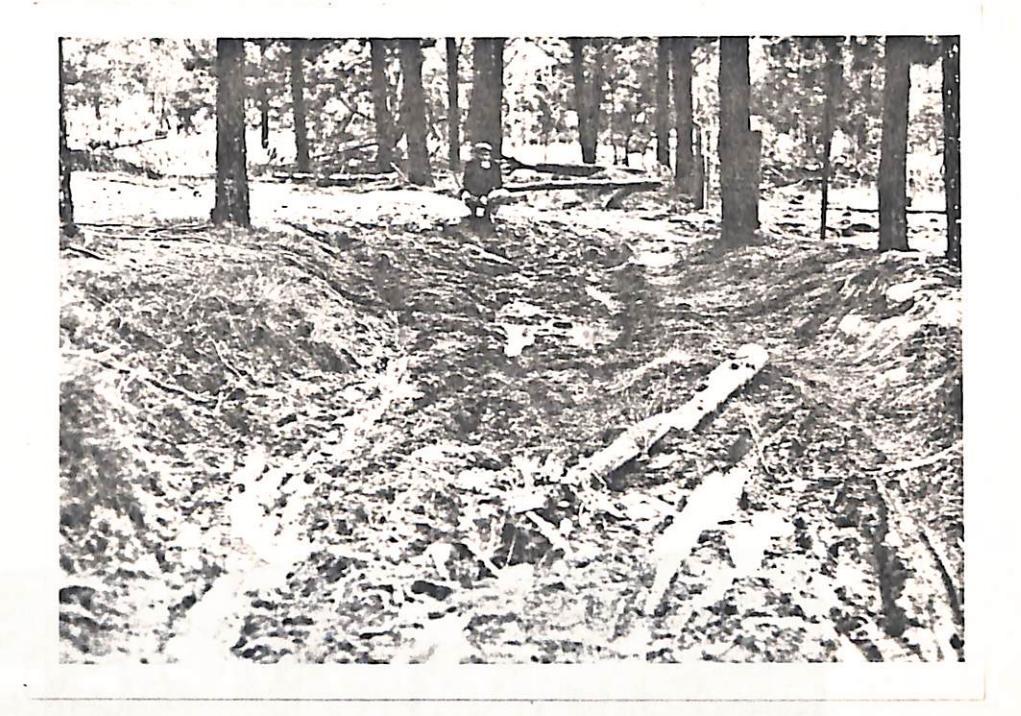
Plate 5 Gully profile experiment site in June, 1974. Note particularly the log in the foreground.

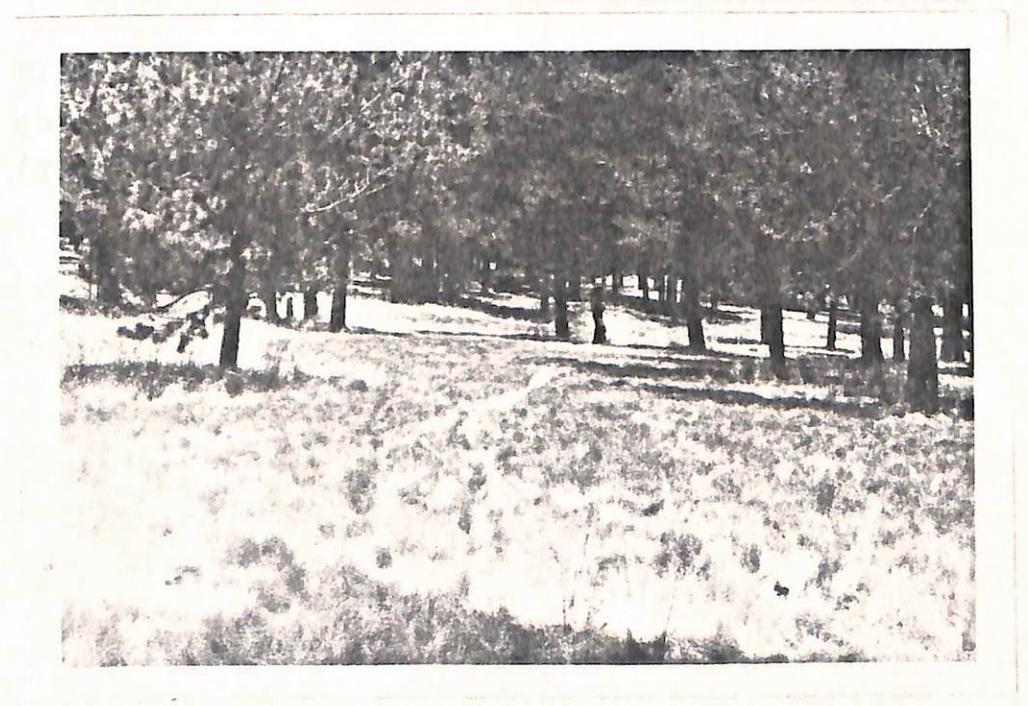
Plate 9 The same area in January 1975. Successful revegetation has been achieved.

The large increase in ground cover was due to a prolific growth of toad rush <u>Juncus bufonius</u> and this can be seen in Plates 8, 9 and 10.

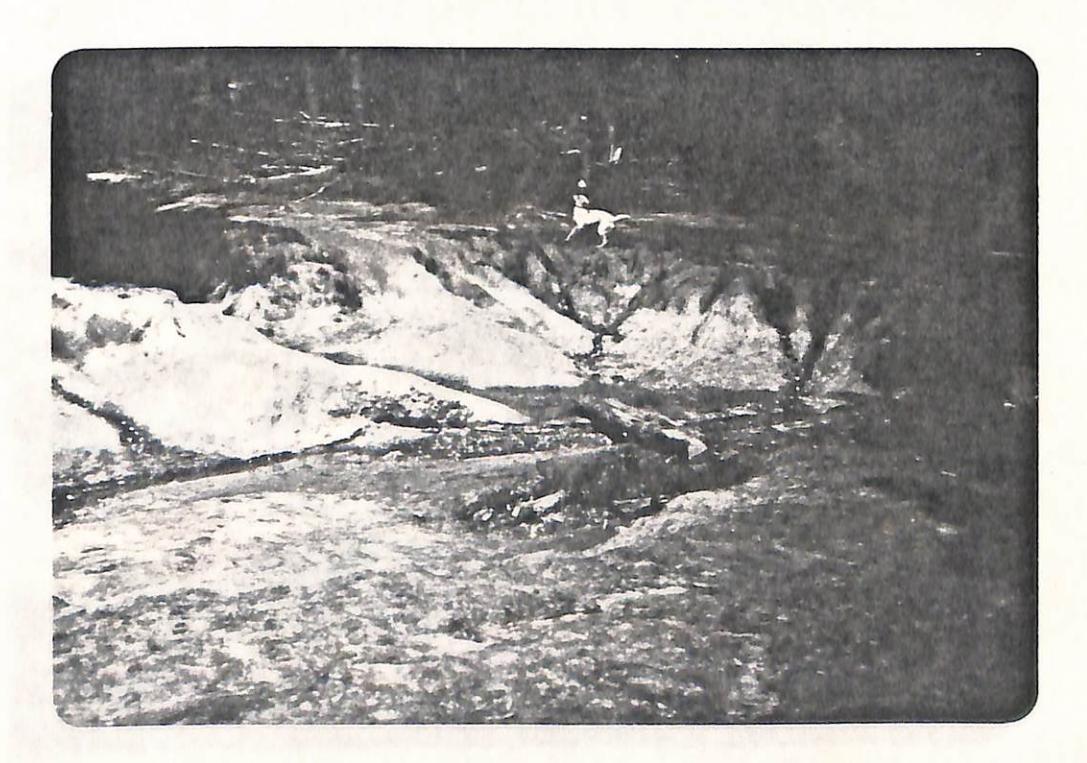
Plate 2 The same section in October 1974, about 3 months after motorcycles were excluded by a fence.

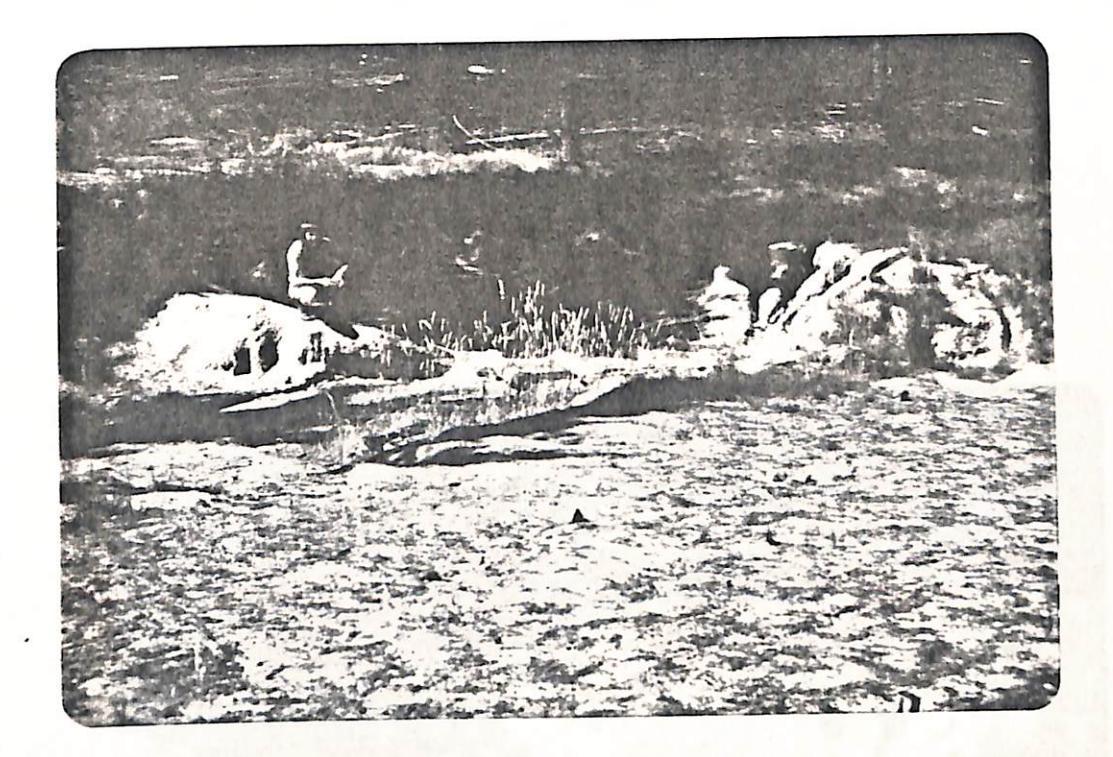
Plate 3 January 1975. Recovery is proceeding slowly. Note the <u>Juncus bufonius</u> (Toad Rush) on the far bank.

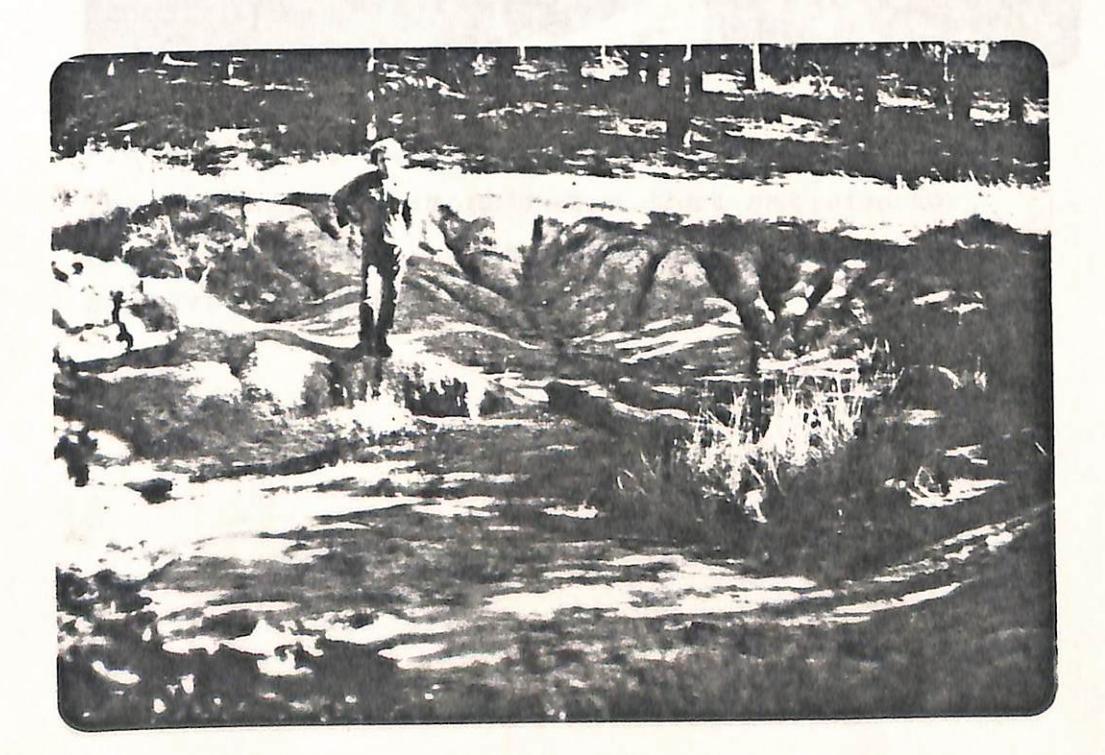
Plate 4 March 1975 Conditions are very dry after the summer. Little change has taken place since January.

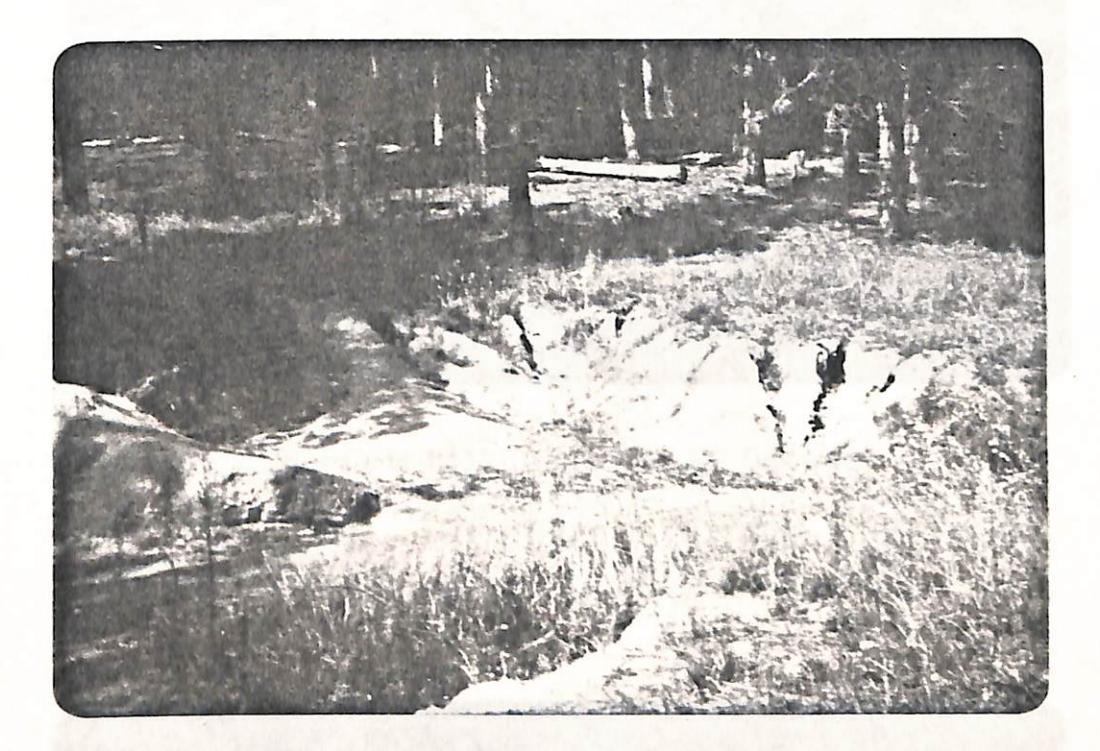
Special attention was given to time lapse photography at the erosion gully in compartment 141. The gully suffered from severe over-use by trail bike riders and was closed off by a fence in July 1974. Plate 1 shows a section of the gully in 1974, about six weeks after the fence was erected. At this stage there is no evidence of recovery. By October (Plate 2) a few green shoots were appearing and in Plates 3 and 4 a gradual recovery can be seen, until by February 1976 (Plate 5) the grass cover is approaching a pre-trail bike damage level.

Plate 5 The same section almost a year later. The photograph demonstrates that satisfactory recovery of trail bike damaged ground can be achieved if usage is discontinued.

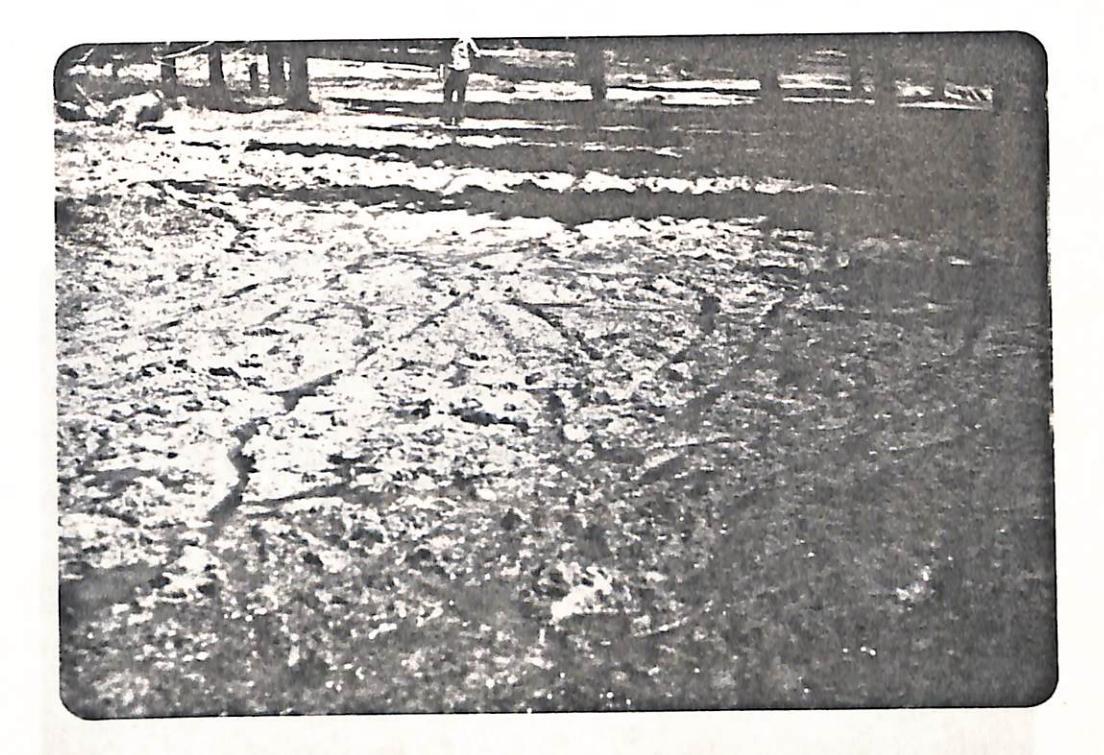
Previous impact assessment reports have described the formation and successful revegetation of quagmires that resulted from over-use of small sections by trail bike riders (see Report Nos. 2 and 4). Plate 6 shows the compartment 141 quagmire in October 1974 following the fencing in July. A good vegetative cover became established in the Spring and early Summer of 1974 and Plate 7, taken in March 1975 shows a cover of Toad Rush, the main recolonising species. Plate 8, taken a year later shows that successful revegetation of quagmires can be achieved. The importance of Toad Rush (Juncus bufonius) as the initial coloniser was seen again at a location near the entrance gate, and this is shown in Plates 9 and 10.

Plate 6 The Cpt 141 quagmire in October 1974

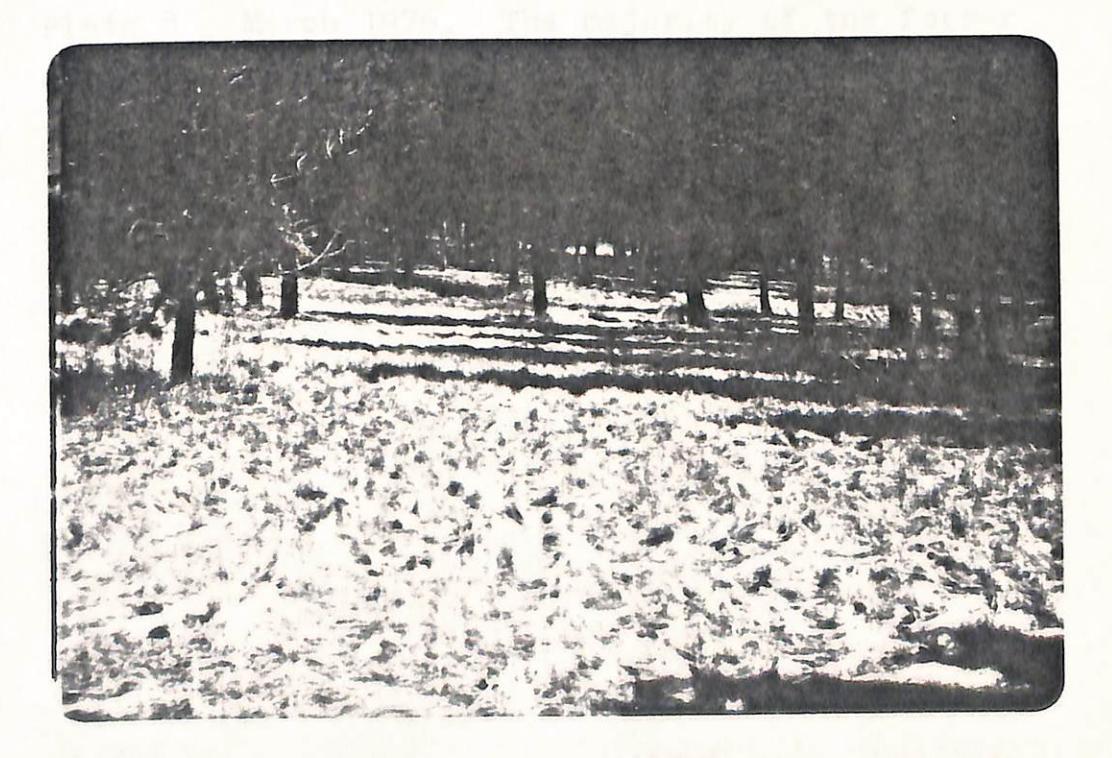
Plate 7 By March 1975 a good cover of <u>Juncus bufonius</u> was established.

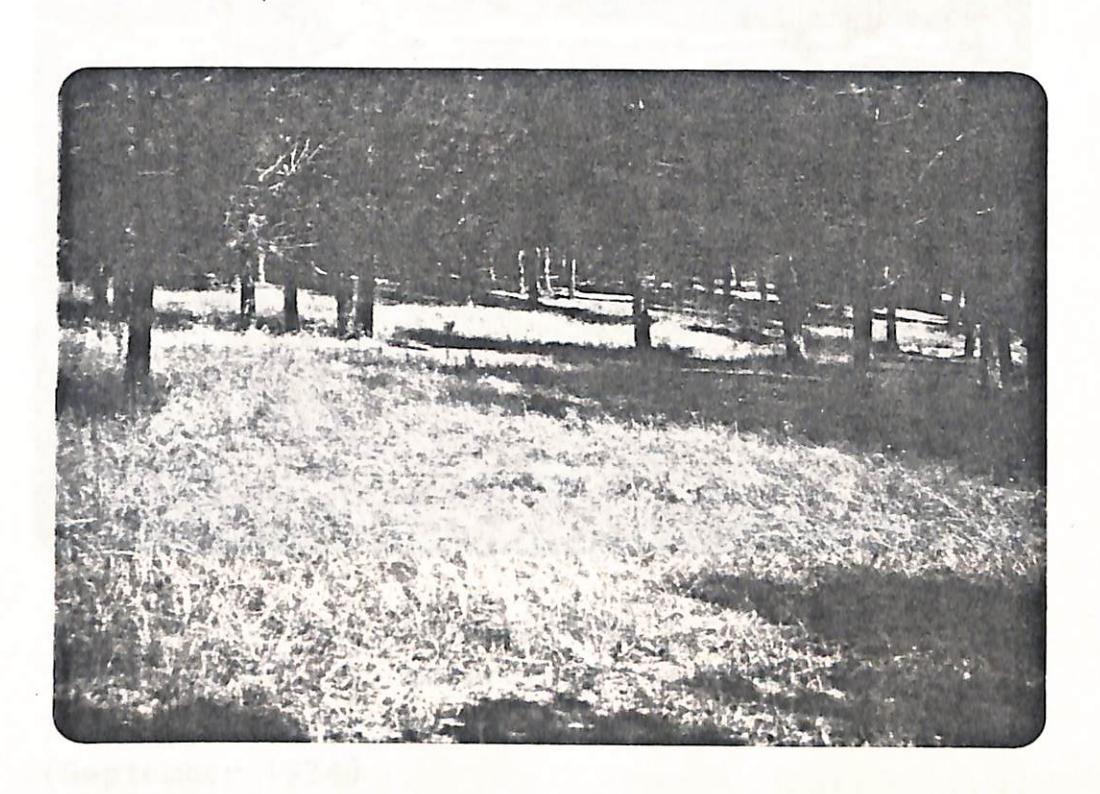
Plate 8 March 1976. The majority of the former quagmire has revegetated.

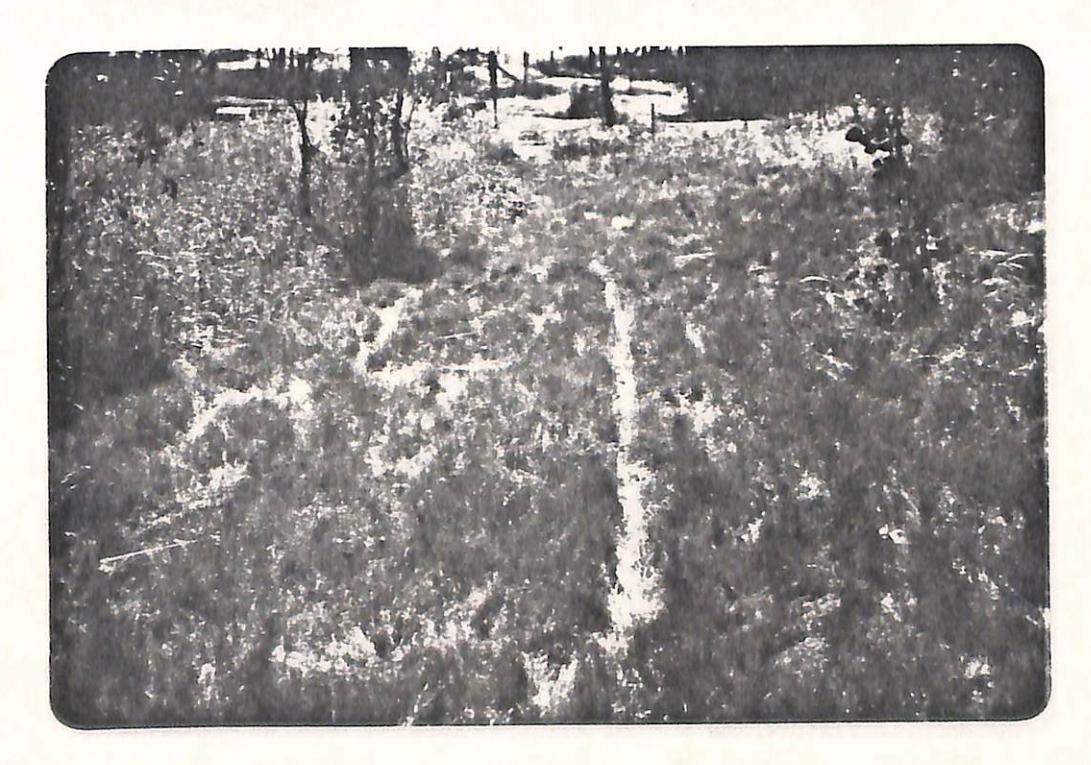
Plate 10 The same area in January 1975, showing a good cover of Juncus bufonius.

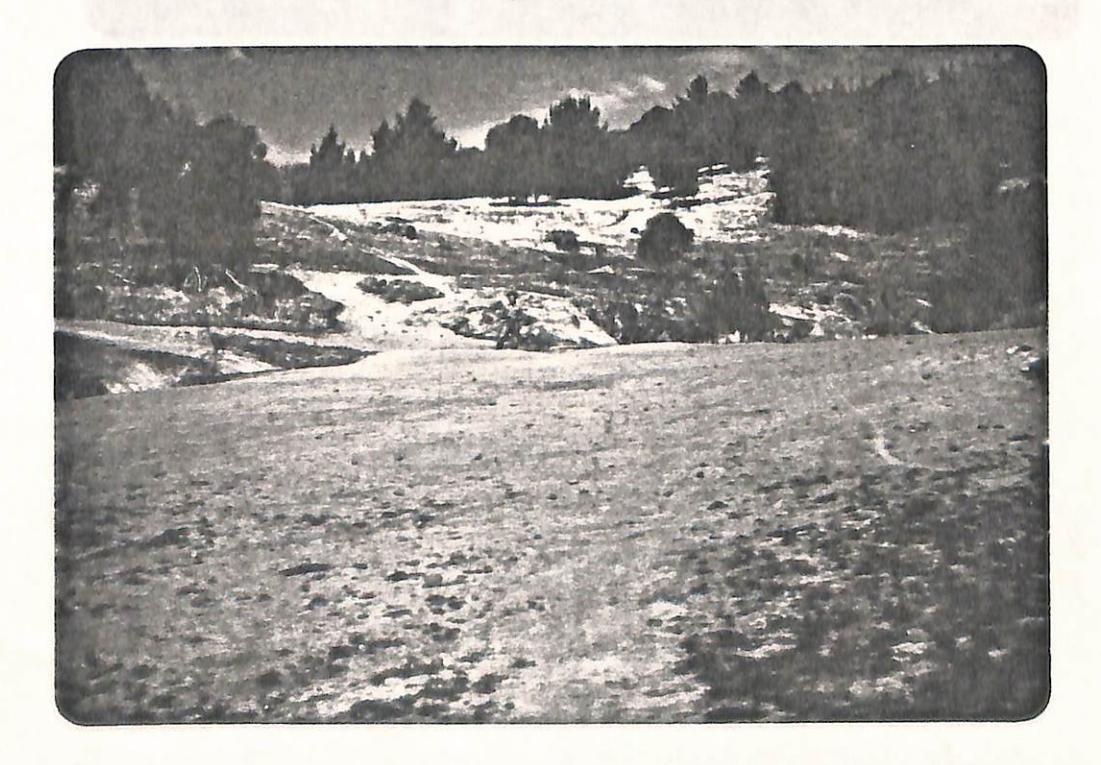
Plate 12 March 1975

The situation at the open section near compartment 146 has been described in Report Nos. 2, 3 and 4. No restoration work of any kind has been undertaken here and the time lapse photography series, (Plates 11, 12 and 13), shows that little, if any revegetation has occurred. It is interesting to note however that the size of the section of bare ground has not increased with time. The same area, viewed from another point on the edge of the hill is shown in Plates 14, 15, 16 and 17.

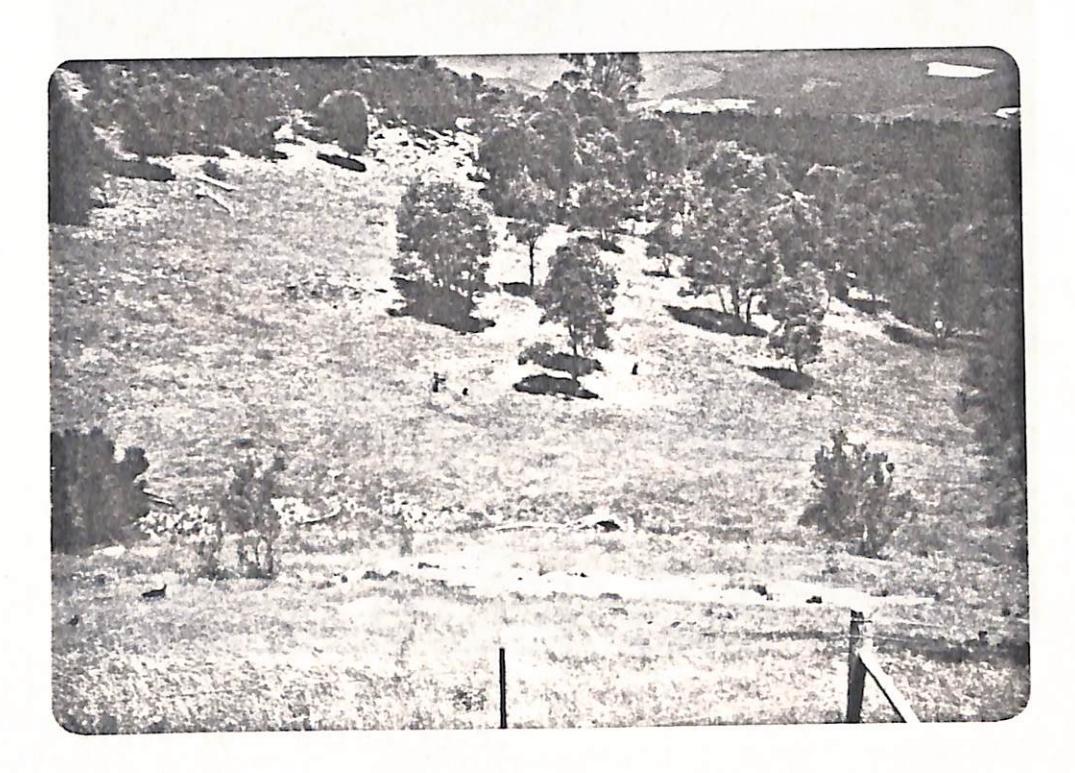
Plate 14 The open section near Cpt 146 before the trail bike area was opened to the public. (November 1973)

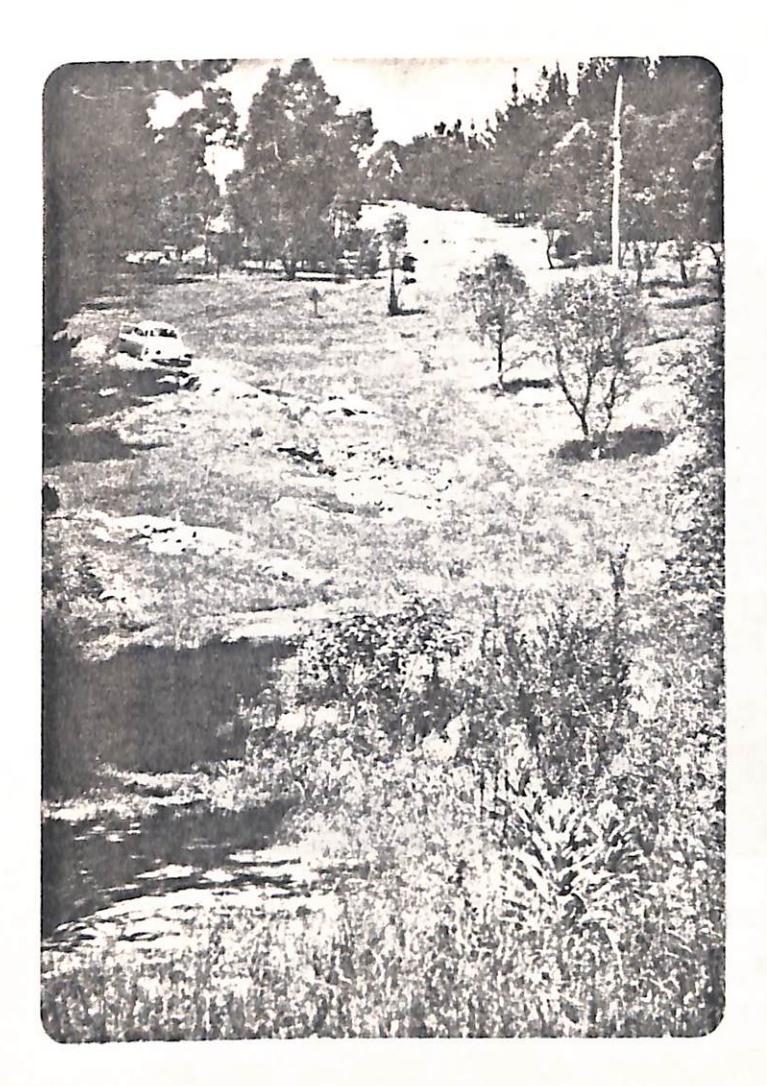
Plate 18 The break between Cpts 144 & 145 shortly before the area was opened to the public (November 1973).

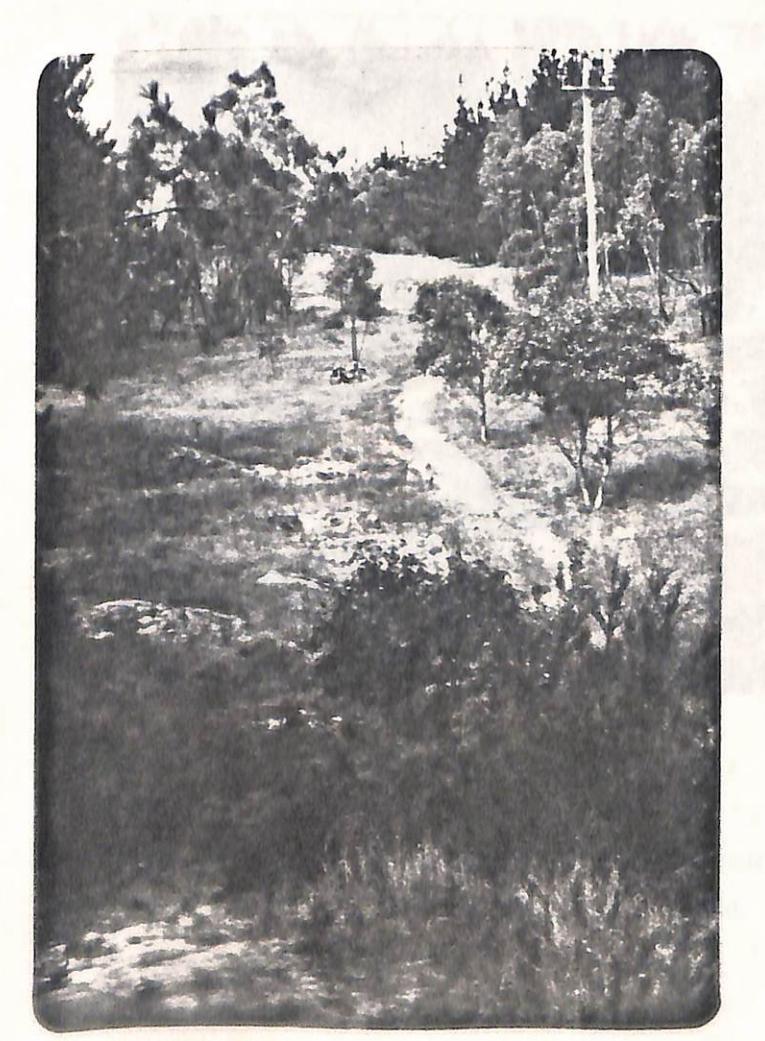
The previous photographs have related to sections where usage by trail bike riders has caused significant disturbance to the soil. There are many examples where continuous heavy usage has resulted in only limited disturbance. Such is the case for the break between compartments 144 and 145. Plate 18 shows the break in November 1973 before the trail bike area was opened. In 1976 (Plate 19) this section is still in good condition, even though it received intense use both on the trail and on grassy sections of the break.

Plate 19 The same break . in February 1976. Despite heavy usage by motorcycle riders, this section is still in good condition.

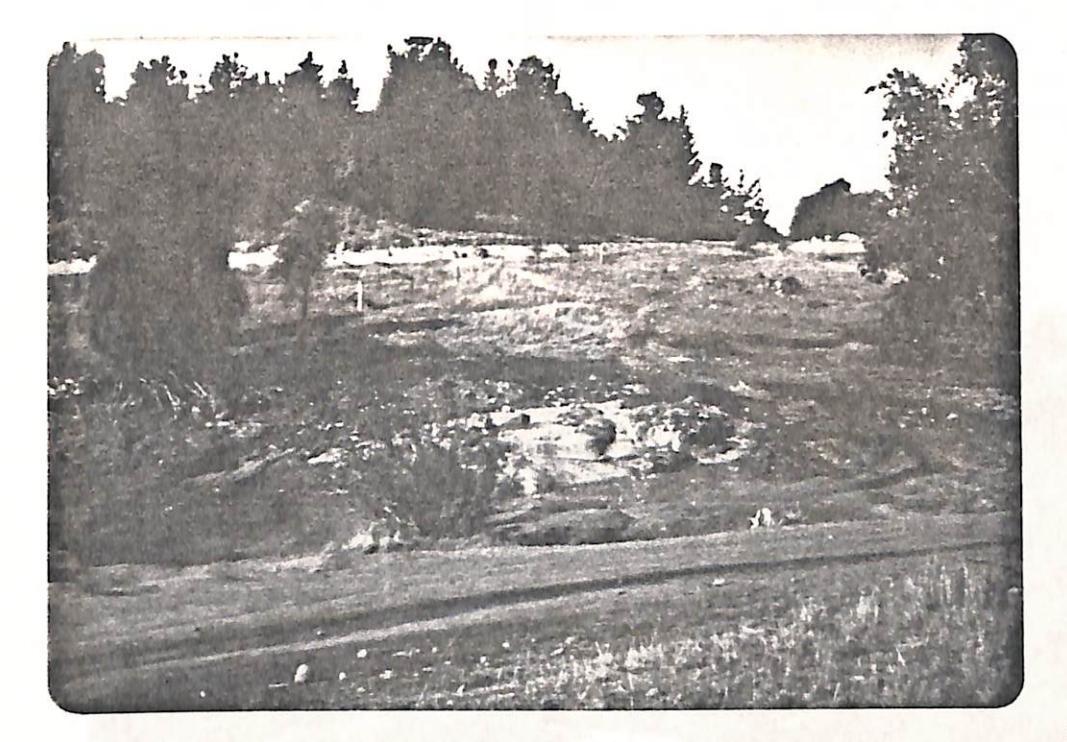
Plate 20 September 1974 - near Cpt 146. In this photograph dry grass and water seepage make impact appear worse than it actually is. (Ektachrome).

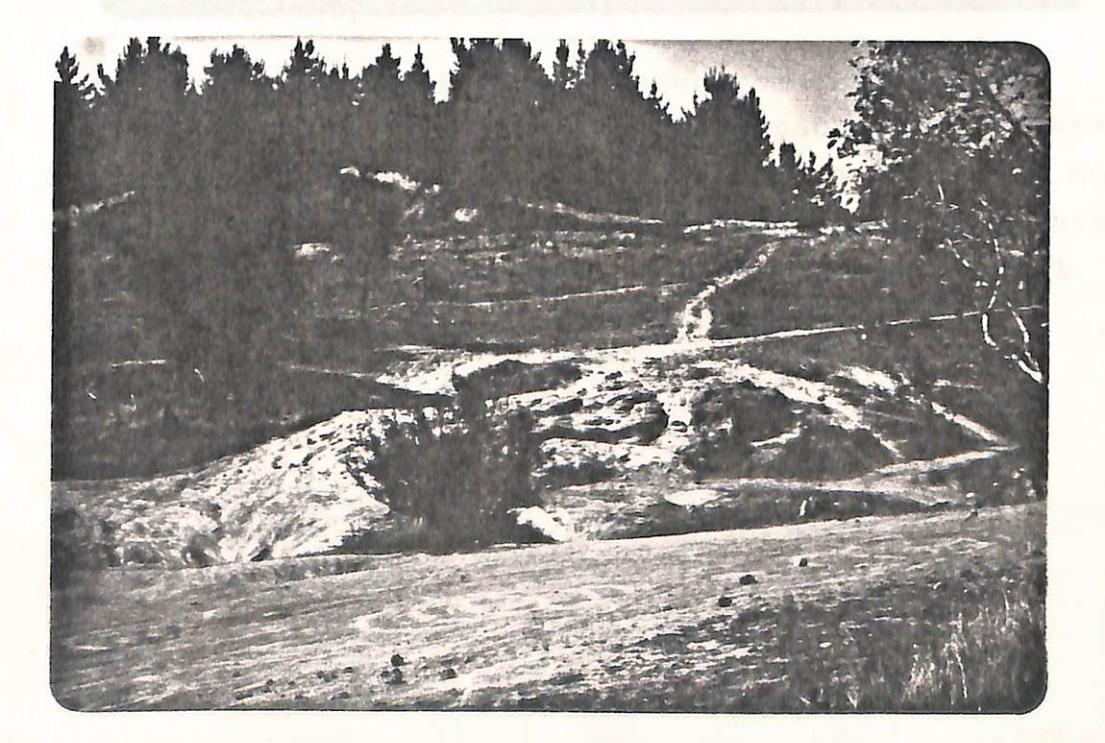
Plate 21 The same area in April 1975. Comparision between this photograph and Plate 20 is complicated because of differences in soil moisture, grass cover and colour, time of day and type of film (Kodachrome).

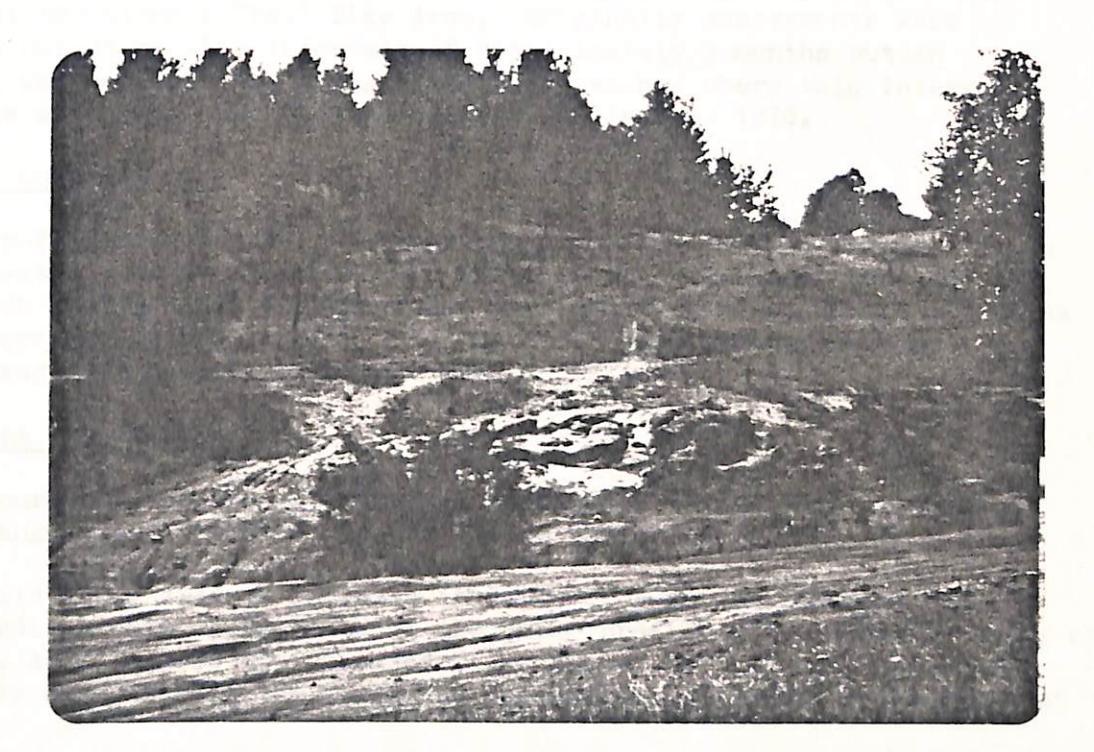
Plate 22 A print from a Kodachrome slide taken in March 1976. In this example impact appears less than in Plate 21 even though the opposite is the case. This results partly from the green grass cover which followed good summer rains. Differences in light conditions are also involved.
