ACT FORESTS BRANCH

STROMLO TRAIL BIKE AREA - IMPACT ASSESSMENT REPORT NUMBER ONE (W.L. Bloomfield, K.J. Roberts, B.J. Terrill)

STROMLO TRAIL BIKE AREA - IMPACT ASSESSMENT REPORT NO. 10 - OCTOBER 1977

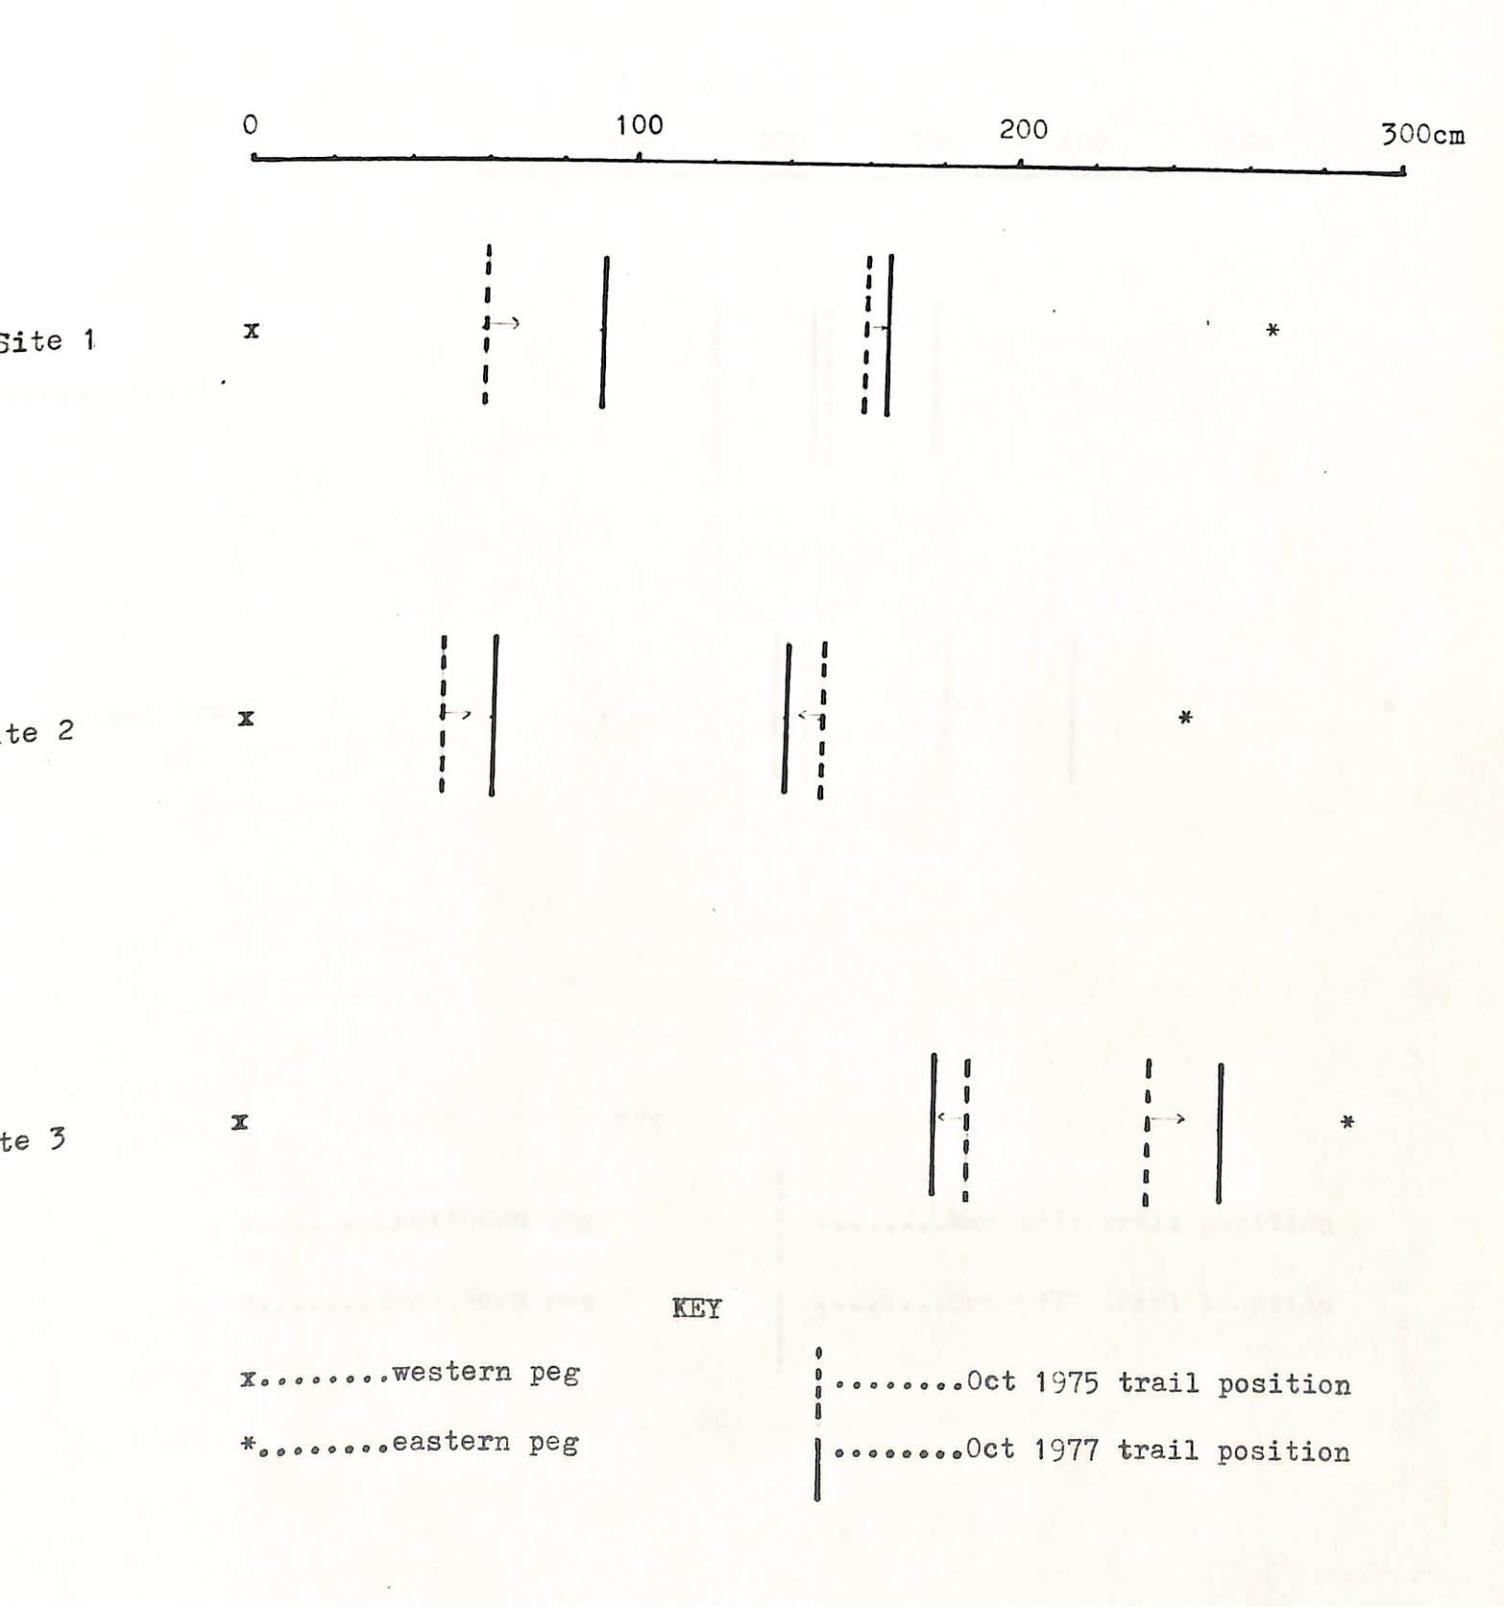
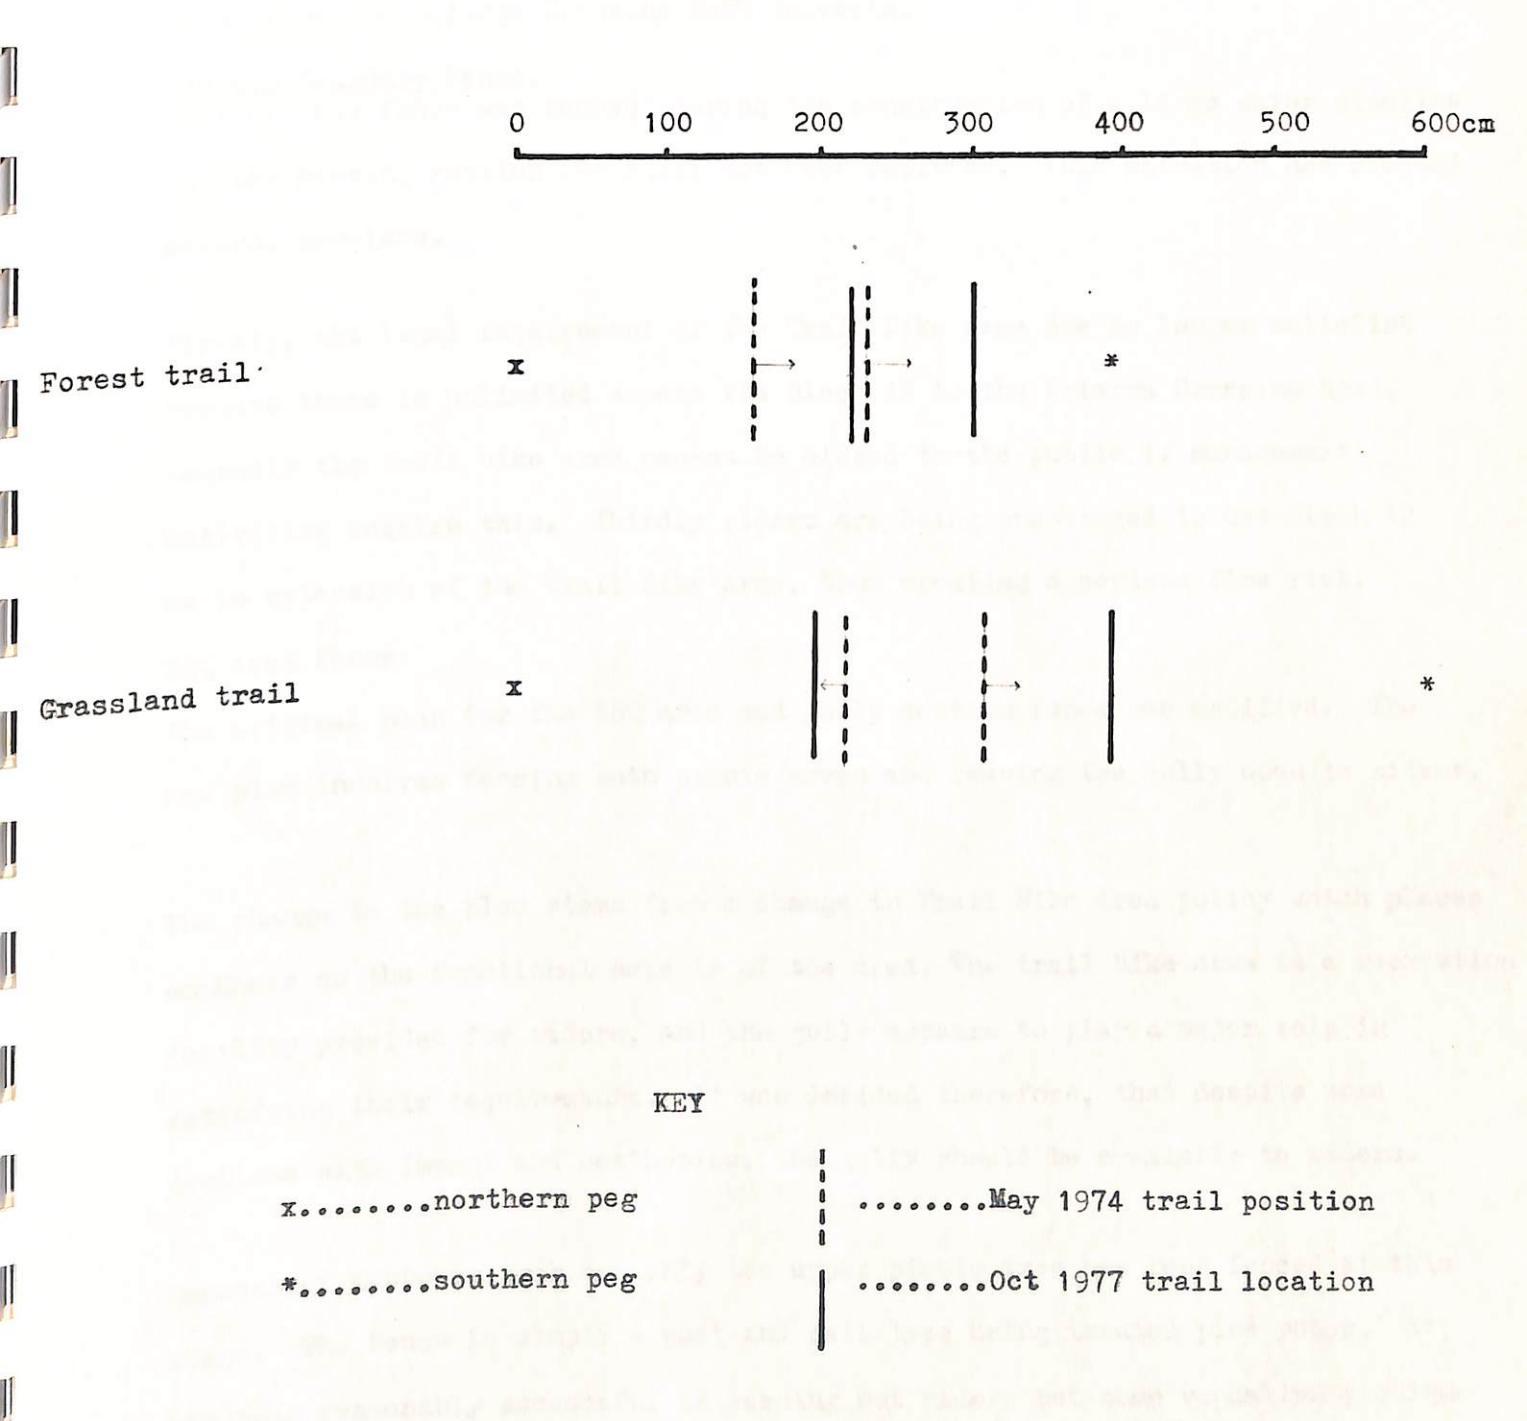
Fig 2 CHANGES IN WIDTH AND LOCATION OF FOREST AND GRASSLAND TRAILS

2. Forest trail in Cpt 141. The present position of this trail compared to 1974 is shown in Fig 2. The trail has a tendency to shift position regularly, thus complicating depth measurement. Depth is always measured in the centre of the trail and a shift in position can, and has, caused considerable variation in depth readings. The alternative is to measure trail depth half way between the two pegs but this method is not used because it could result in measurement at a point where the trail is no longer used.

3. Grassland trail between Cpts 144 & 145. Trail depth at this site has increased by 4 cm since 1974. Width has increased (see Fig 2)

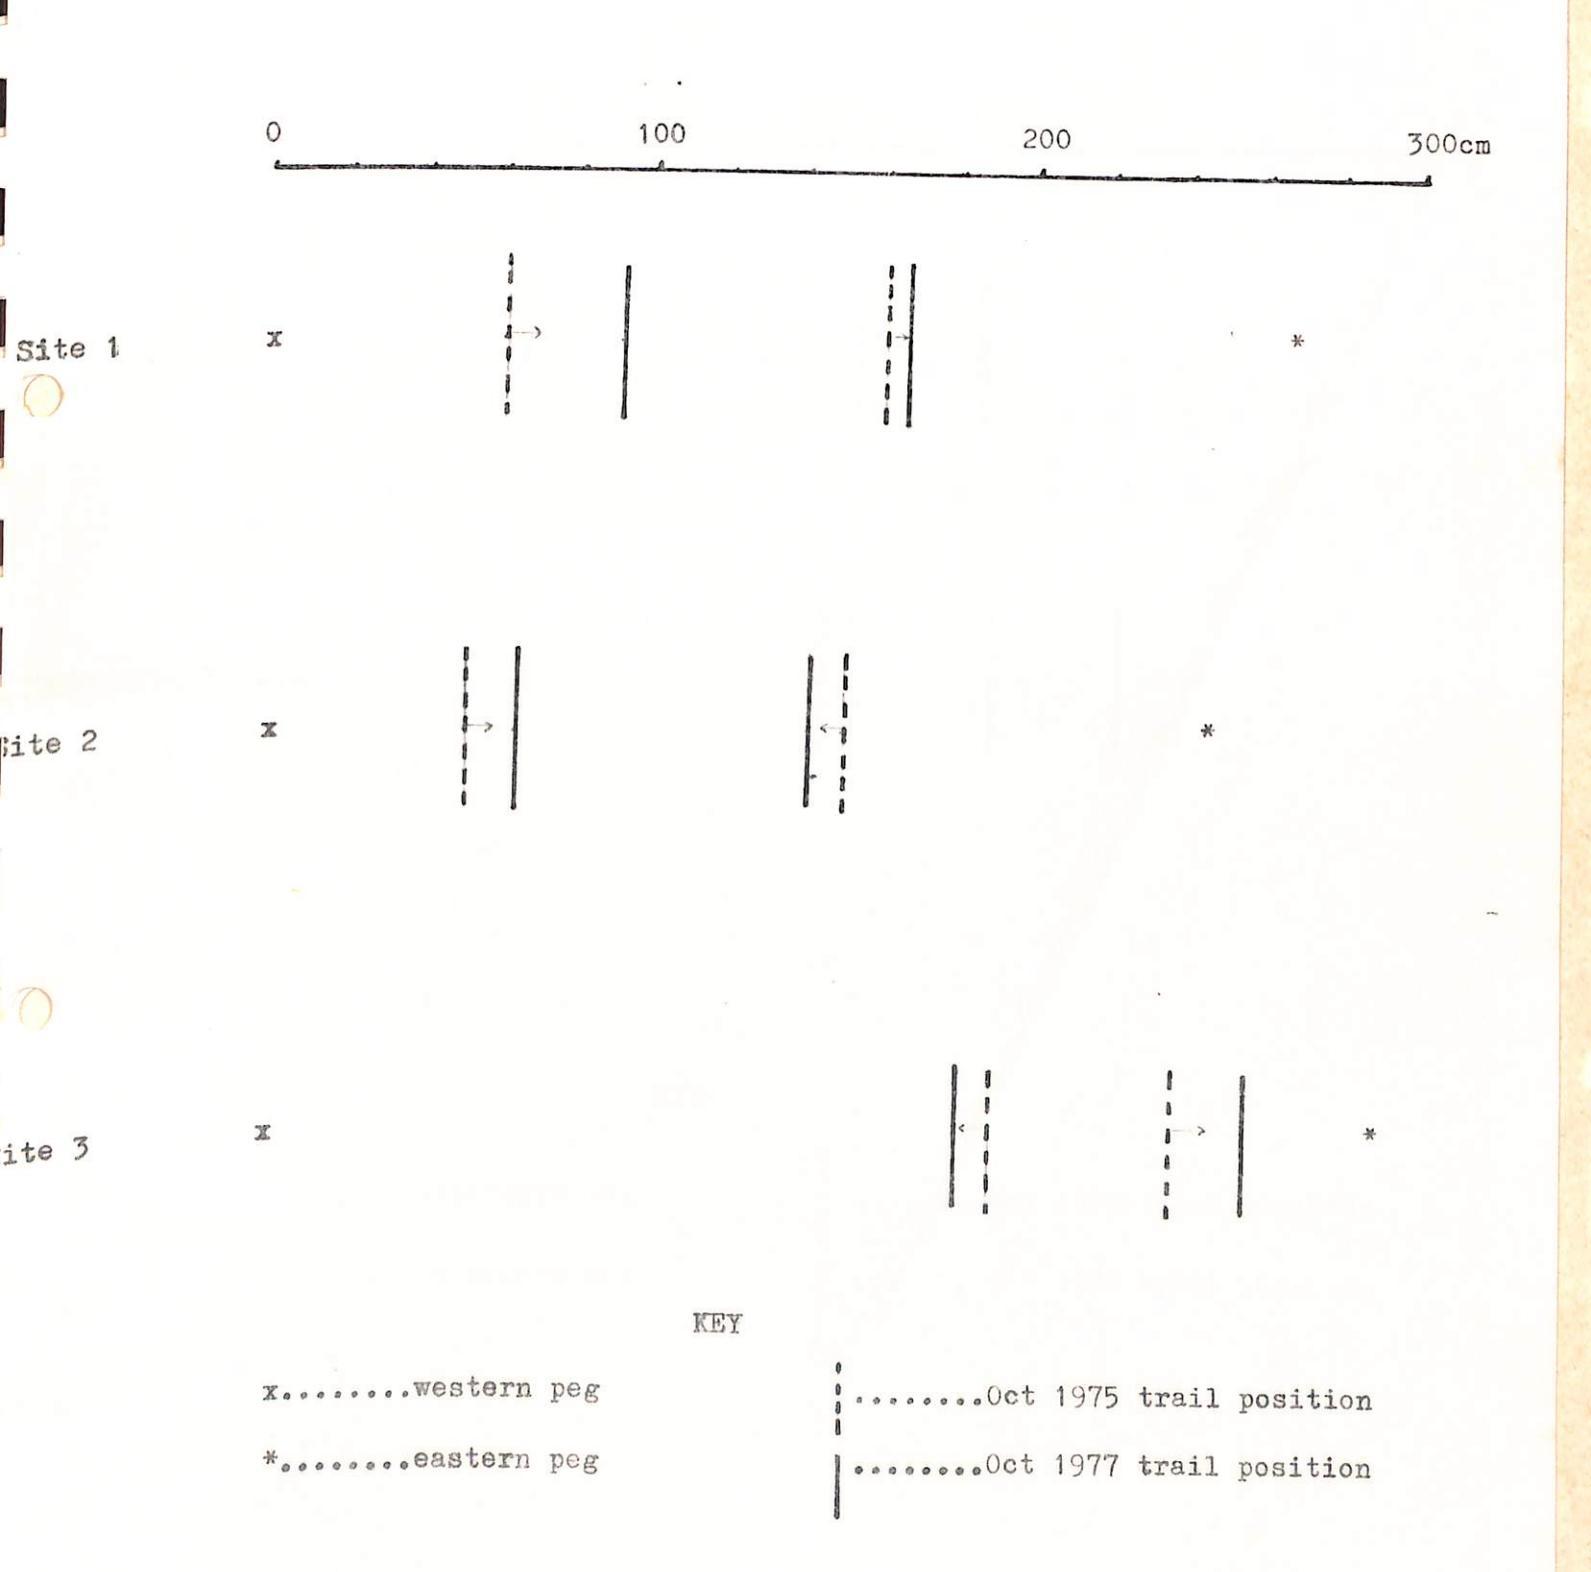
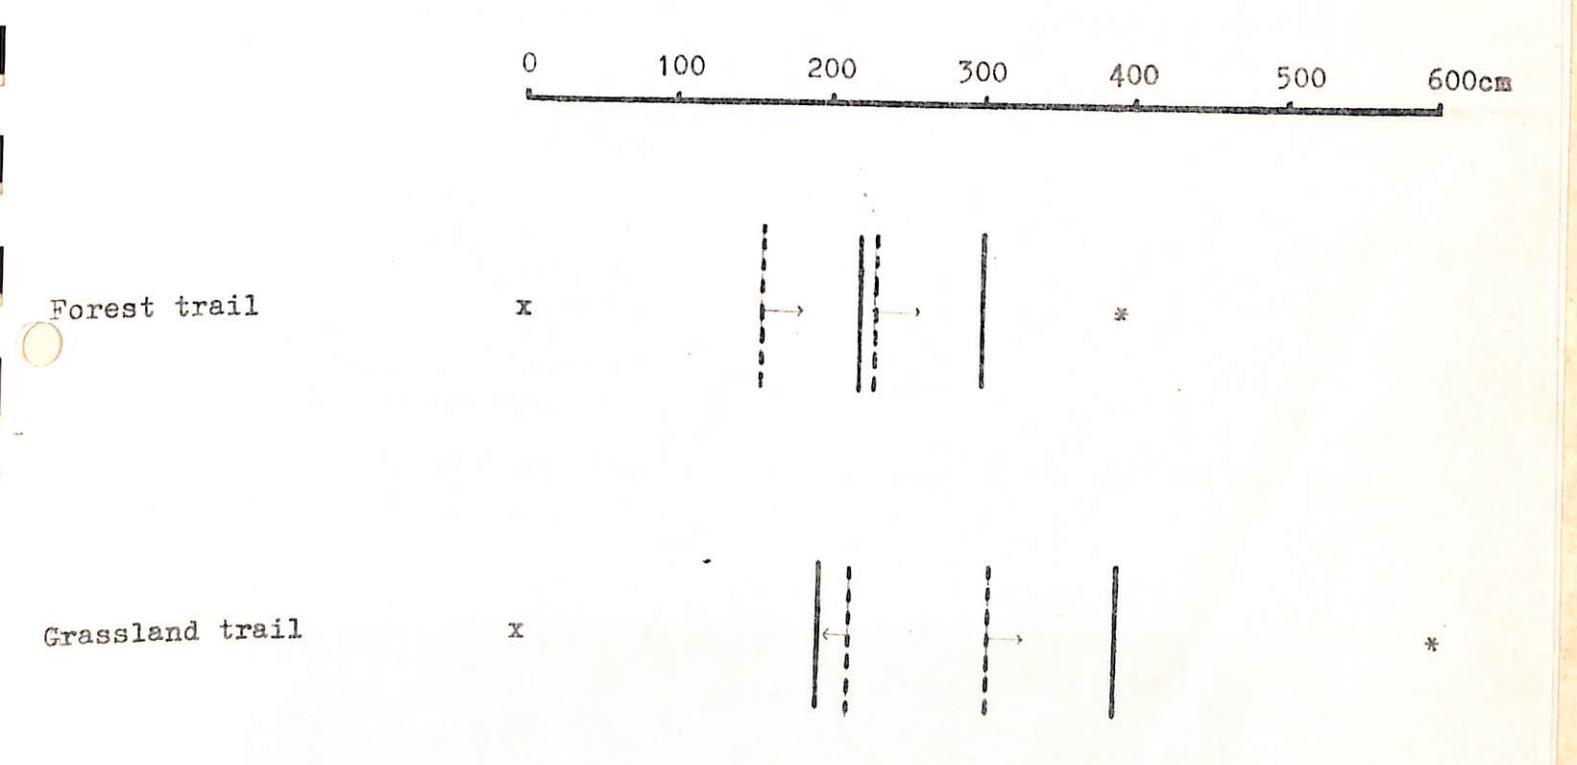
2. Forest trail in Compartment 141. The present position of this trail compared to 1974 is shown in Fig. 2. The trail has a tendency to shift position regularly, thus complicating depth measurement. Depth is always measured in the centre of the trail and a shift in position can, and has, caused considerable variation in depth readings. The alternative is to measure trail depth half way between the two pegs but this method is not used because it could result in measurement at a point where the trail is no longer used.

3. Grassland Trail between Compartments 144 and 145. Trail depth at this site has increased by 4 cm since 1974. Width has also increased (see Fig. 2).
