Turf for tough times

—keeping grass cover with less water

Proceedings of a seminar held at Cleveland, 6 June 2007

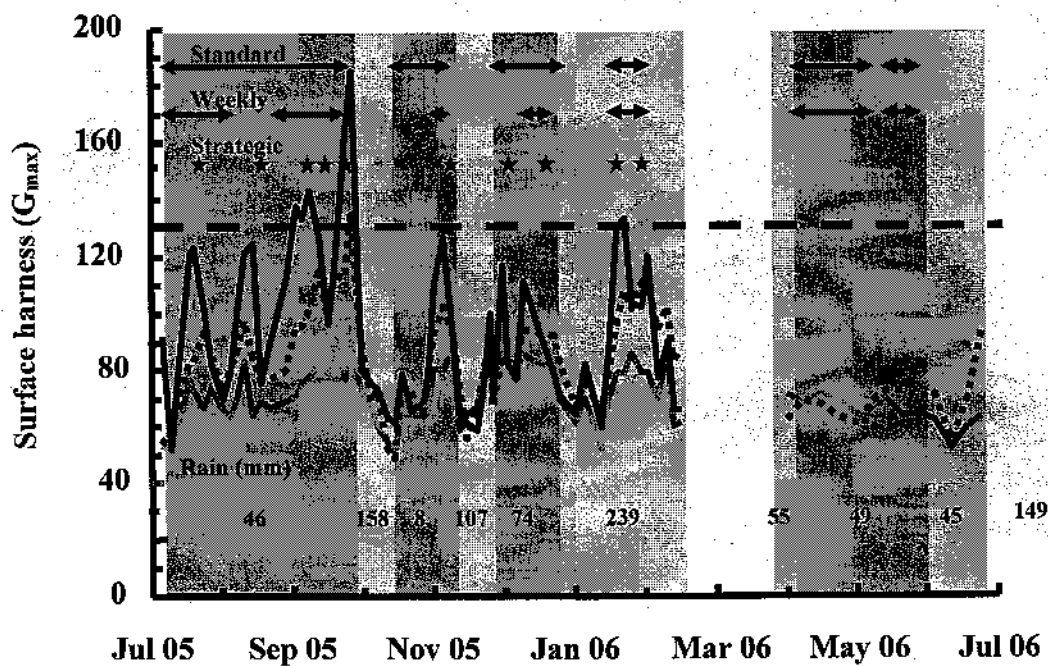
At Mt Gravatt (Figure 8), the standard irrigation kept the site uniformly moist, and hardness remained constantly low for the whole period. The surface of the weekly irrigation site dried out slightly during the early October dry spell, with hardness gradually increasing, but only reached a value of 130 G_{max} just before the October rain. From then on it remained at less than 110 G_{max} .

At Mt Gravatt the strategic irrigation site was interesting and informative. The curator had previously suggested this was a 'difficult' area, which always seemed to dry out and need watering before other parts of the field. Our results confirmed that this site did behave differently, with a very strong relationship between soil moisture content and surface hardness. Its surface water content was always lower than other parts of the field, and it had concerning levels of field hardness on several occasions between irrigations.

As an example, the field was waterlogged by 75 mm of rain on 6 November 2005. Eight days later, following a week of fine weather, 50 mm of evaporation and no irrigation, hardness on the strategic irrigation site reached a level of 110 G_{max} (even though the turf was not showing any signs of stress), compared to 80–90 G_{max} on the other two irrigation sites.

Figure 8: Impacts of irrigation treatments on surface hardness at Mt Gravatt sports field, between July 2005 and June 2006. Arrows for standard and weekly treatments show periods when irrigation was operational (otherwise turned off by rain sensor or manually). Stars for the strategic treatment show the irrigation event. The horizontal dotted line shows the current acceptable hardness level for community fields. Background shading shows low rainfall periods. The solid black line represents the strategic irrigation treatment readings. Standard irrigation surface hardness readings are in light grey. The dotted dark line gives readings for the weekly irrigation treatment.

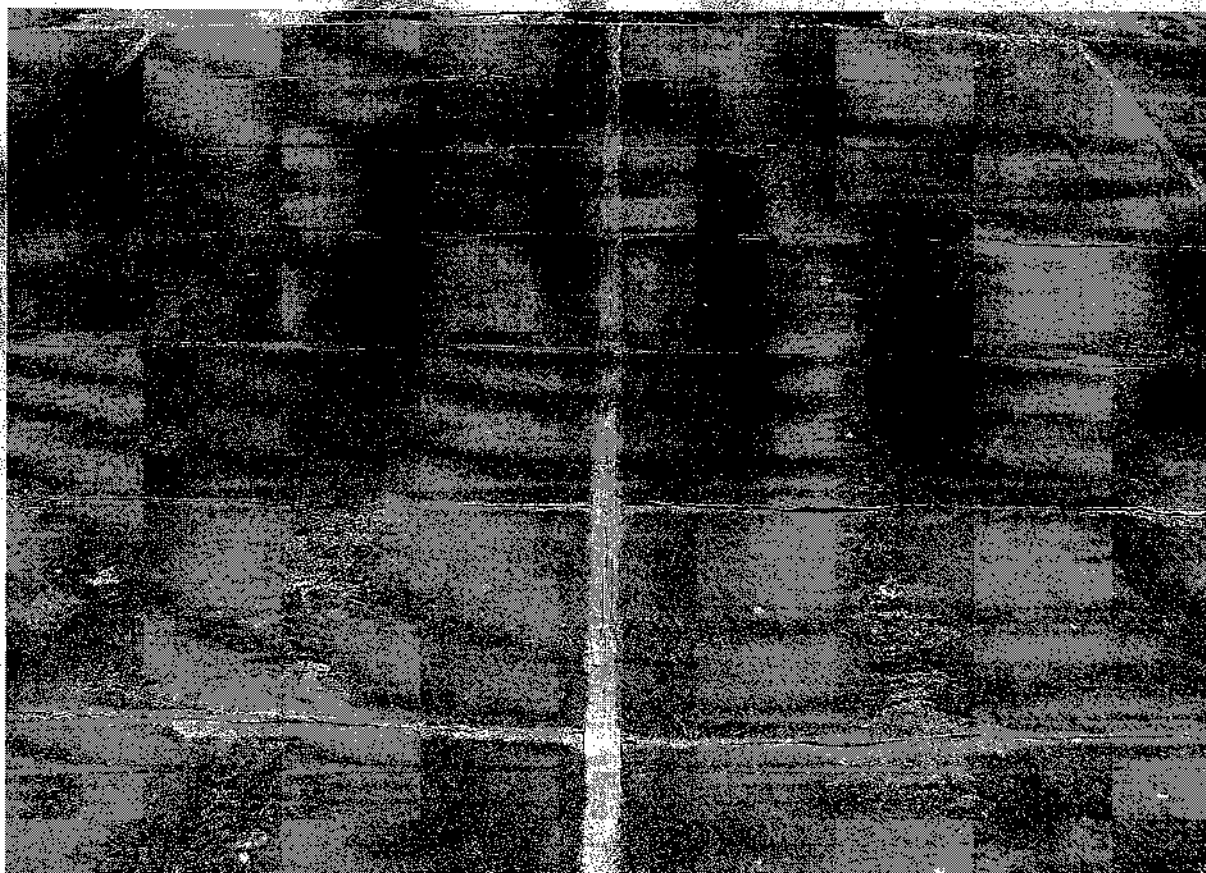
Plate 1. Aerial view of wear damage (6 October 2006).
